SHORT CONTINUOUSLY REINFORCED CONCRETE PAVEMENT  
DESIGN RECOMMENDATIONS BASED ON NON-DESTRUCTIVE  
ULTRASONIC DATA AND STRESS SIMULATION

Thesis submitted to the Polytechnic School of  
the University of São Paulo in partial  
fulfillment of the requirements for the degree  
of Doctor of Science in Engineering

Concentration field: Transportation  
Engineering

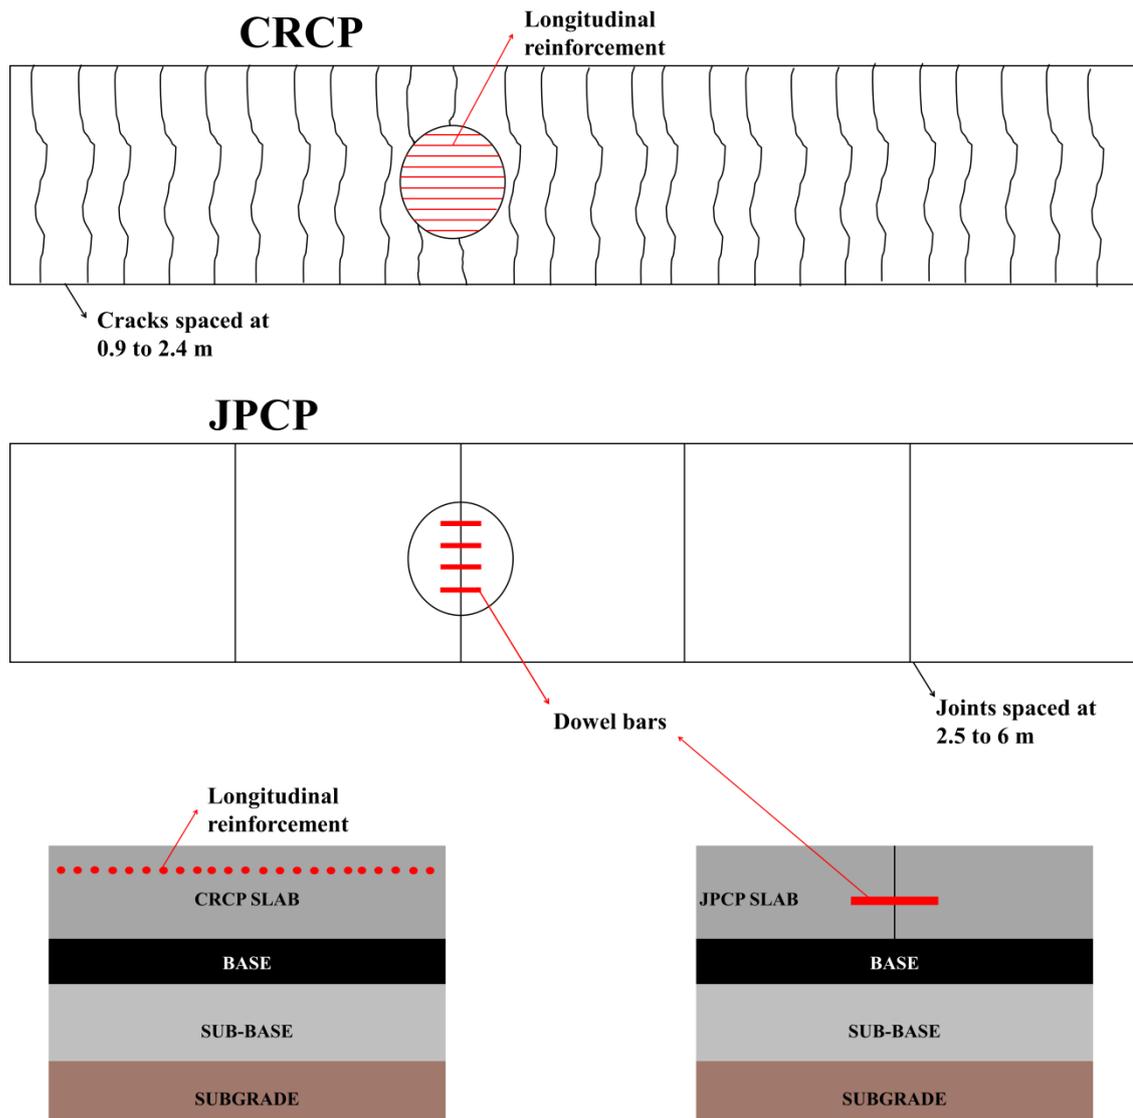
Figure 1. 1– Basic design and structural differences between CRCP and JPCP (Adapted from SALLES and BALBO, 2015)

In order to keep focus on concrete structures while mitigating the joint-related issues, this thesis proposes the use of continuously reinforced concrete pavements (CRCP) as a potential pavement solution for bus corridors stops and terminals. CRCP is a concrete pavement without contraction joints. The concrete slab has no length restriction as long as the concreting continues. Only when the concrete pouring has ended or stopped is a constructive joint performed. Common knowledge says that concrete being a very fragile material has a high cracking tendency, both in its fresh and hard states. Due to this unwanted property, contraction joints are needed in JPCP; by slab sawing cut, it is possible to induce/control cracks in a place where the dowel bars will provide load transfer between slabs. The CRCP's concrete shows no different behavior – it still cracks. The major difference between CRCP and JPCP is that the former has a high steel percentage placed above the slab's half-height. The major role of this reinforcement is to keep the inevitable cracks tight, thus making their presence imperceptible to the user and providing highly satisfactory load transfer between cracks by means of aggregate interlock. Therefore, there is not a crack control or inducement because of the whole steel structure designed to maintain the slab's structural and functional integrity (ROESLER *et al.*, 2016). Figure 1.1 illustrates the major differences between JPCP and CRCP.

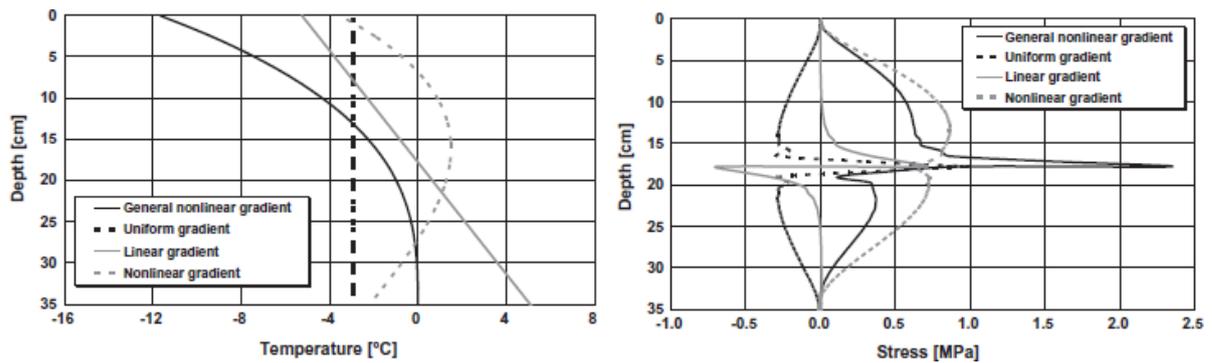
Figure 2. 1 - Effect of differential thermal gradients in slab stresses (CHOI *et al.*, 2011)

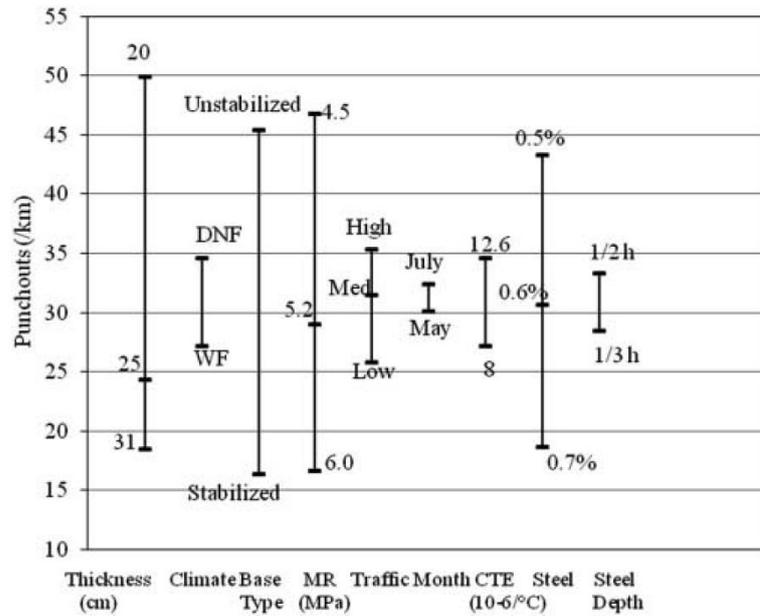
Figure 2. 3 - Sensitivity analysis of the MEPDG prediction model (VANDENBOUSSCHE *et al.*, 2012)

The main factors are slab thickness, base type, concrete tensile strength and longitudinal reinforcement percentage. Although not mentioned in the paper, the sensitivity analysis does not always meet the maximum recommended values of punchout per mile of 6 to 13.

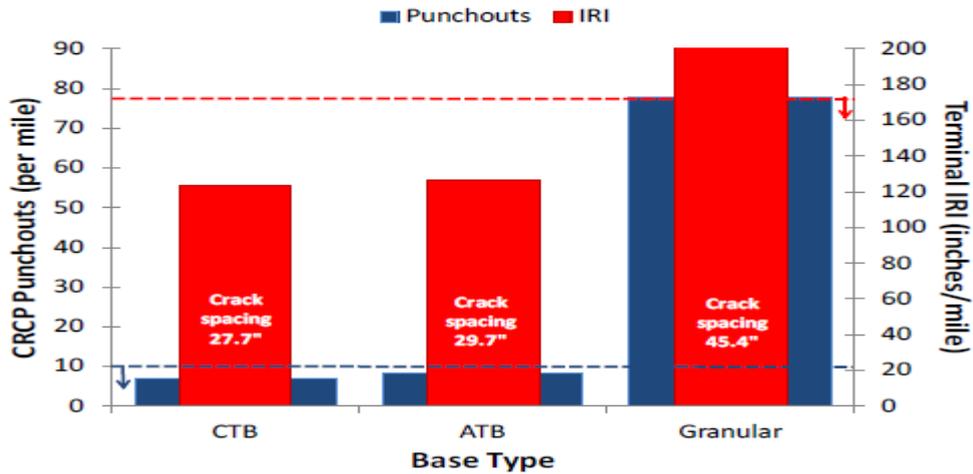
Figure 2. 4 - Effect of stabilized bases in CRCP performance (ROESLER e HILLER, 2013)

A key aspect that has become the rule in the CRCP design is the use of stabilized bases with low erosion potential. Roesler and Miller (2013) attest to this criterion when comparing bases stabilized with cement (CTB), with asphalt (ATB) and granular. In Figure 2.4 the performance difference regarding punchouts and IRI is notable. For several US transportation departments, the maximum number of per mile punchouts ranges from 6 to 13 and the maximum IRI is set at 2.7 m/km (170 inches/mile). Although the authors did not compare the type of stabilization, through Figure 2.4 it is possible to intuit that the cement stabilized material presents similar performance to the asphalt material. This only occurs in stabilizations with low binder percentage. Several authors have demonstrated the asphalt base superiority in other studies (LEE and DARTER, 1995; GHARAIBEH *et al.*, 1999; JOHNSTON and SURDAHL, 2006)

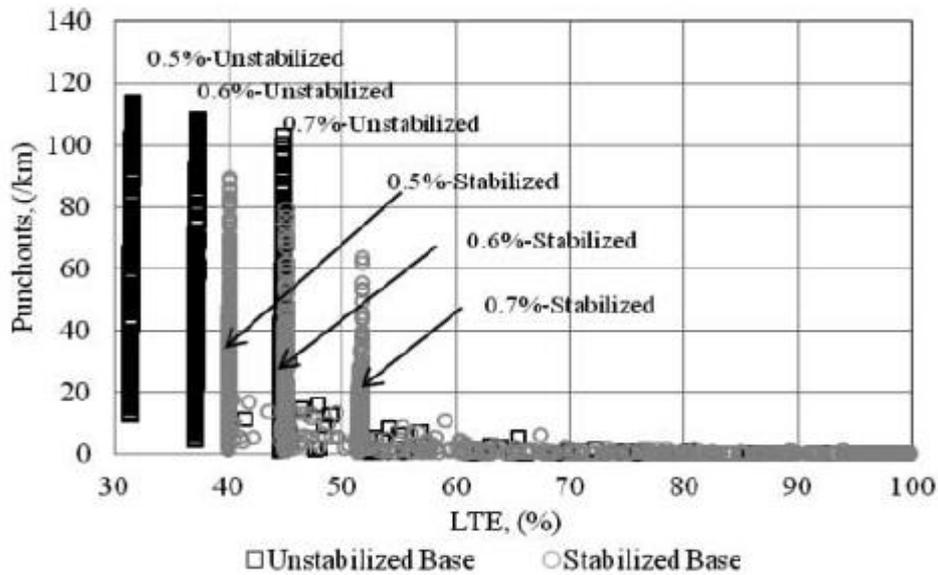
Figure 2. 5 - Effect of base type and LTE in CRCP performance (VANDENBOSSCHE *et al.*, 2012)

The stabilization benefits are understandable. In addition to prevent the inner layers erosion, stabilized bases can increase tensile strength introducing greater rigidity (Zhang, 2012). This also goes in agreement with the sensitivity (MEPDG) study performed by Vandebossche *et al.* (2012). According to the authors, using a stabilized base or no is more influential in damage potential with low crack LTE. However with high LTE, base stabilization does not seem so important, as shown in Figure 2.5

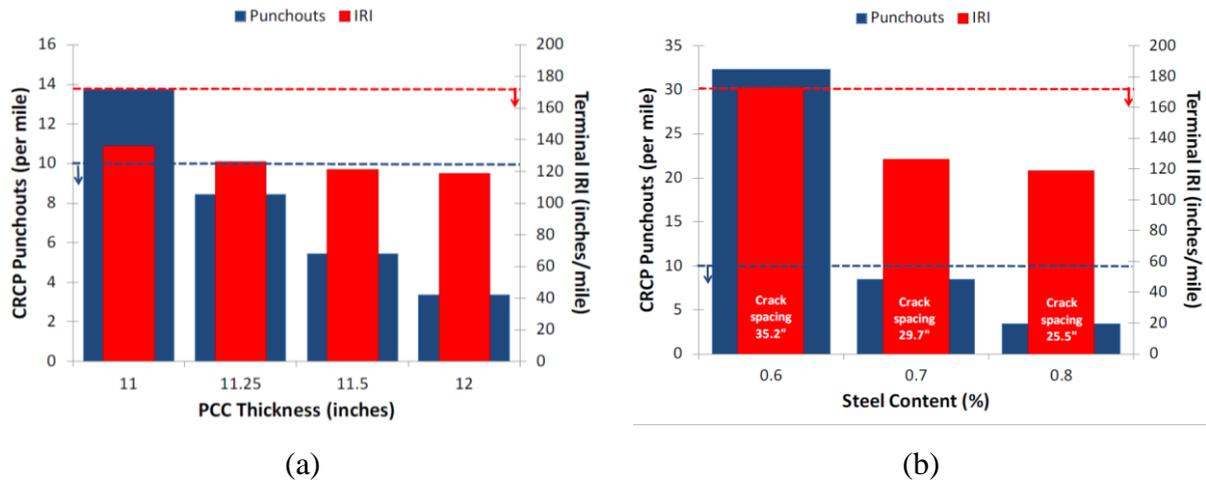
Figure 2. 8 – Punchout number regarding: (a) slab thickness and (b) steel amount (ROESLER and MILLER, 2013)

Regarding slab thickness it is intuitive to think that the thicker the slab, more resistant is the structure. Roesler and Hiller (2013) state that due to the sensitivity of the tensile strength and thickness relation, even the smallest change in this parameter radically modifies the pavement behavior as evidenced in Figure 2.8a. Furthermore, a greater thickness, logically, provides a greater area of contact between aggregates, which increases LTE. As for the steel percentage, it is an established CRCP knowledge that the greater the steel amount, the greater the number of cracks, the smaller the crack spacing and width and the better the performance (Figure 2.8b). Although some authors have not found a relationship between large crack spacing and low crack LTE, most design models adopt this criterion. The fact is that the crack width influences the crack’s behavior much more than the spacing between them. However care must be taken when approaching excessive steel percentages (greater than 1%) which can generate an abnormal number of cracks. These cracks, although having minimum widths can intersect each other facilitating punchout development. According to MEPDG recommendations, cracks should not be spaced more than 1.8 m to ensure tighter cracks.

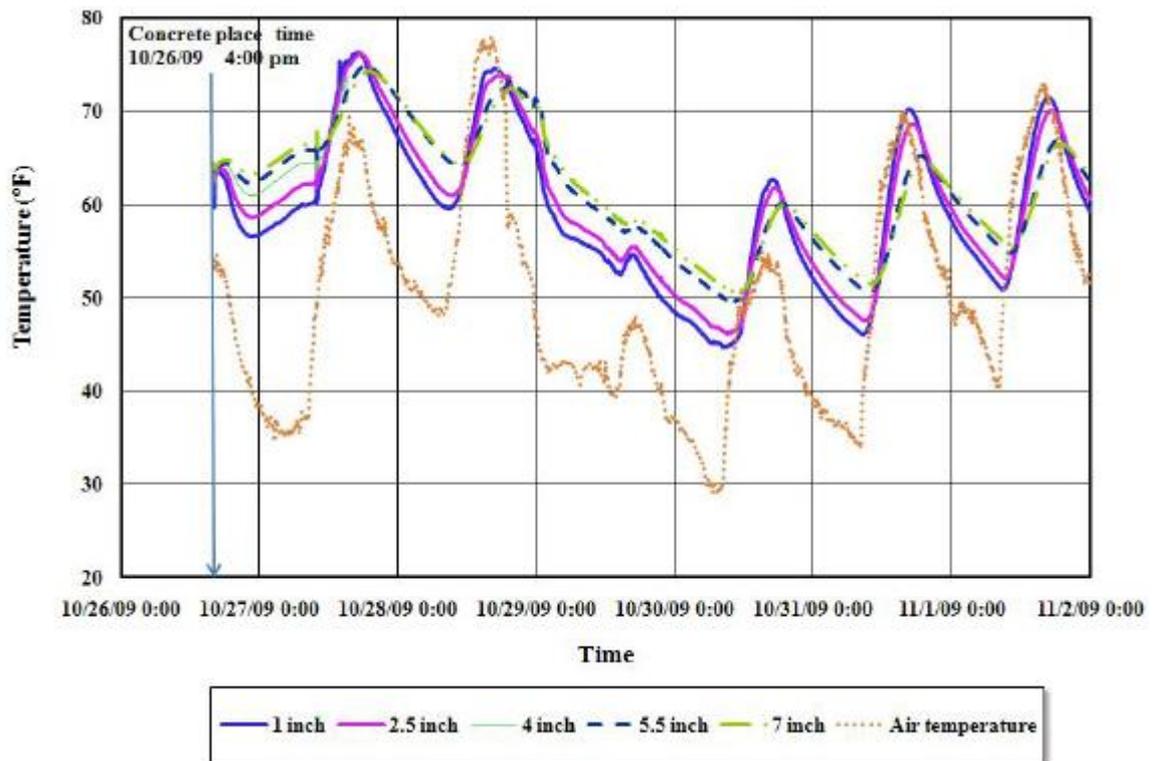
Figure 2. 11 – Temperature variations near the edge (SUN *et al.* 2011a)

In a study conducted in six lanes (180 mm thick slabs) instrumented with Vibrating Wire Strain Gages and Steel Strain Gages, the authors observed that the deformations are larger near the longitudinal edge. Rises in temperature increase deformations. Over time, the tendency is the same but the deformation levels are smaller. The air temperature influences the concrete temperature mainly on the surface as shown in Figure 2.11.

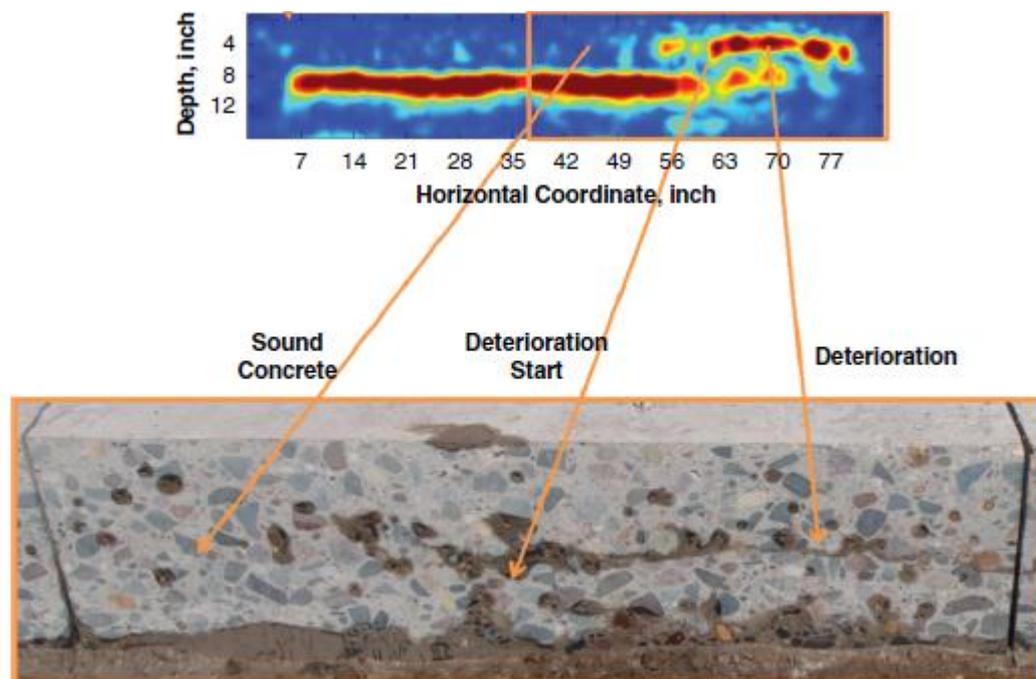
Figure 2. 20 – Forensic evidence of delamination presence in a concrete slab (HOEGH *et al.*, 2013)

For example, with the compilation of various readings it is possible to reconstruct in a 2D image the exact position of a distress (Figure 2.20). Forensic analysis of the slab shows the device accuracy which was also able to correctly indicate the slab thickness of approximately 230 mm (9 in.). Compared with other methods, ultrasonic evaluation with MIRA showed the best correlation with the destructive forensic studies (HOEGH *et al.*, 2013).

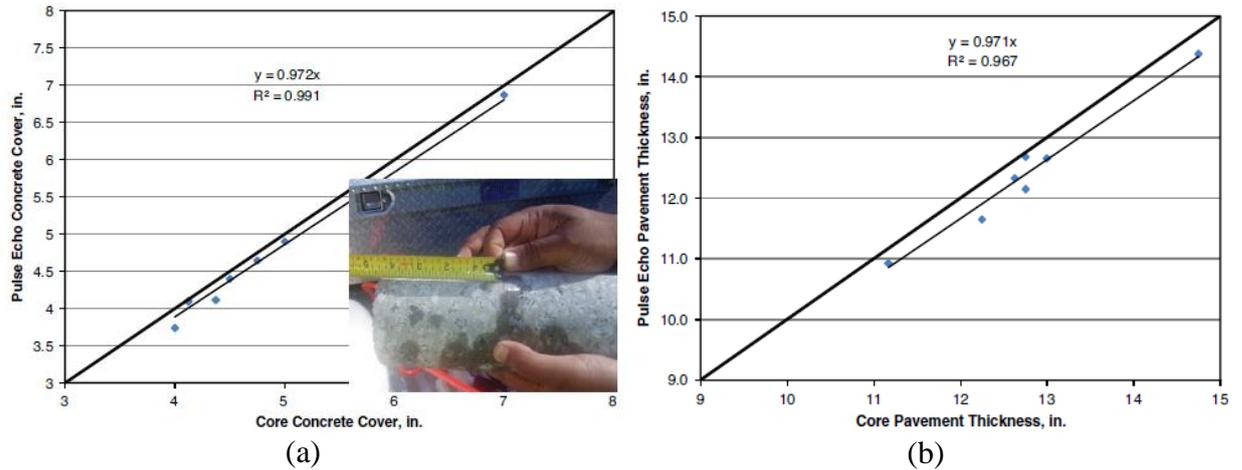
Figure 2. 22 – Correlation index between the cores and MIRA of (a) concrete cover and (b) slab thickness (HOEGH *et al.*, 2011)

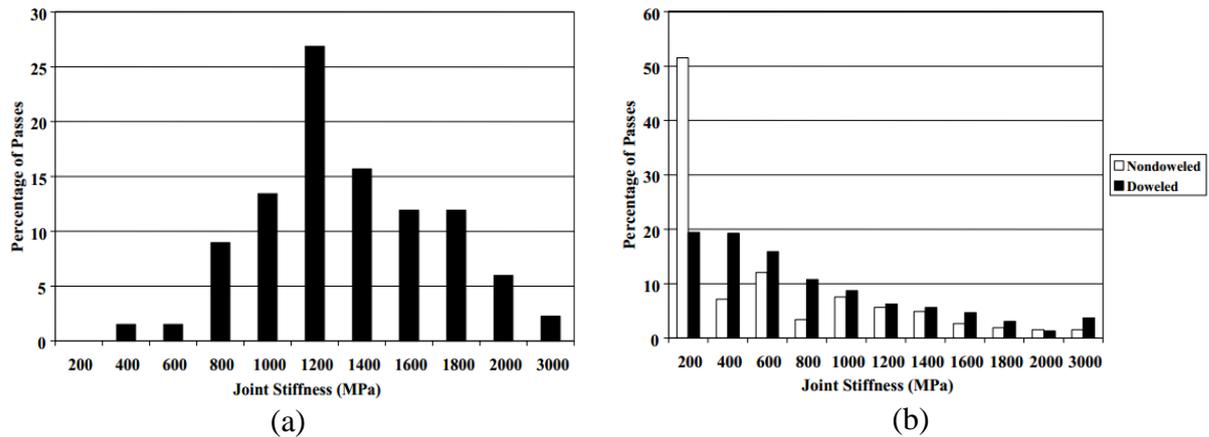
Figure 2.31 - Stiffness distribution of (a) cracks and (b) joints (KHAZANOVICH and GOITLIF, 2003)

For LTPP data, the stiffness variations in CRCP cracks and JPCP joints are shown in Figure 2.31. Average stiffness for cracks and joints was 1240 and 730 MPa, respectively.

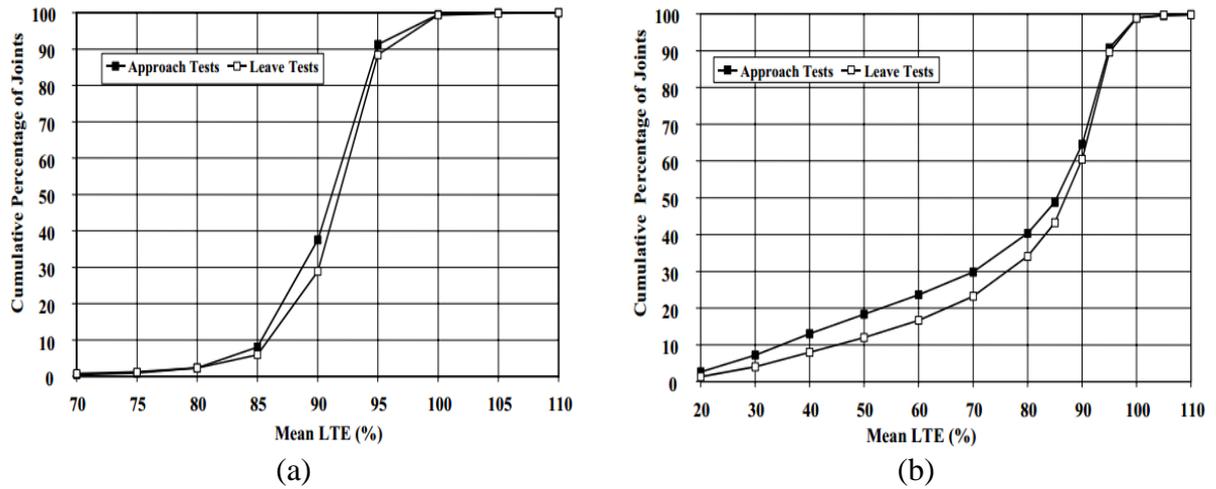
Figure 2. 32 - Distribution of LTE mean values in (a) cracks and (b) joints (KHAZANOVICH and GOITLIF, 2003)

The FWD position also impacts LTE as demonstrated by Khazanovich and Gotlif (2003). In Figure 2.32, results of joints and cracks deflection data from LTPP are presented. When the load is applied in the second slab relative to traffic direction, LTE is lower than when the load is applied to the first slab. This outcome is more influential in JPCP joints than CRCP cracks. The authors could not explain this difference, but the finding is important to standardize the survey methodology. Also notable is the worst performance of JPCP joints when compared to CRCP cracks.

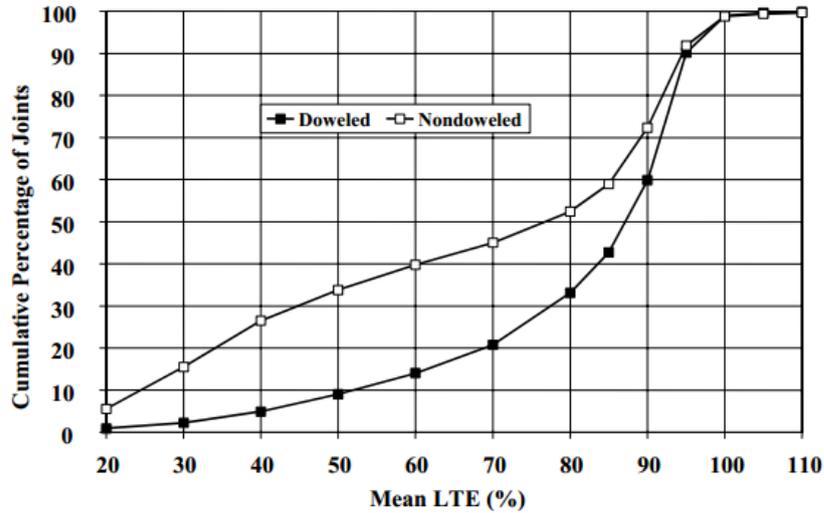
Figure 2. 33 - Doweled and nondoweled joints LTE asses (KHAZANOVICH and GOITLIF, 2003)

As expected the LTPP LTE results show that joints without dowel bars exhibit lower LTE than joints with the device (Figure 2.33). However, an increase in bar diameter does not have the expected effect. Intuitively, a thicker bar would carry a greater load percentage, in addition to having greater contact area with the concrete resulting in higher LTE. Yet Figure 2.34 suggests the lack of influence of bar diameter in LTE.

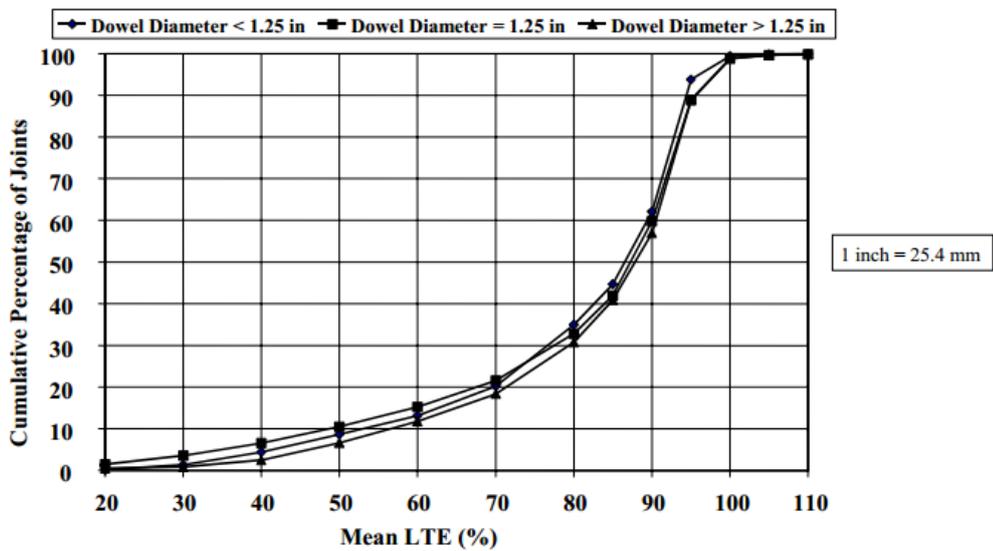
Figure 2. 34 – LTE versus dowel diameter (KHAZANOVICH and GOITLIF, 2003)

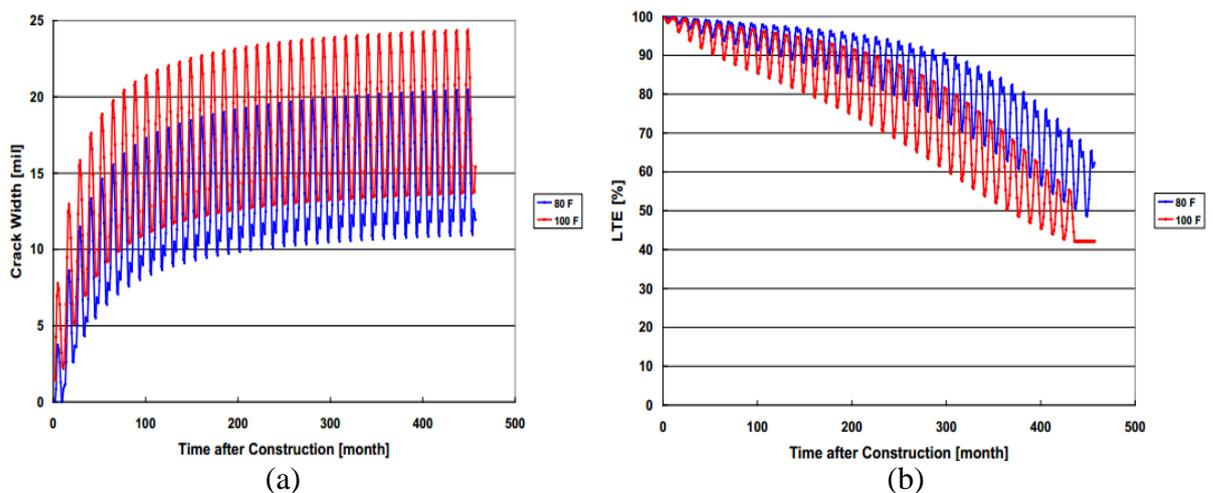
Figure 2. 36 – (a) Crack width and (b) LTE variation over time for two temperature settings  
(HA *et al.* 2012)

Ha *et al.* (2012) tested the MEPDG sensitivity to CRCP based on crack width and LTE variation for two construction temperatures. Figure 2.36 shows the results. Pavements built at higher temperatures (100°F = 38°C) have more open cracks and therefore a lower initial LTE. With time this difference worsens to the point where, after 20 years, there is a 20% LTE gap between the two temperatures. However, the authors state that LTPP and Texas Department of Transportation data indicate LTE high values (above 90%) for CRCP with over 30 years of traffic exposure. Tests conducted in the summer and winter in the same cracks showed no differences.

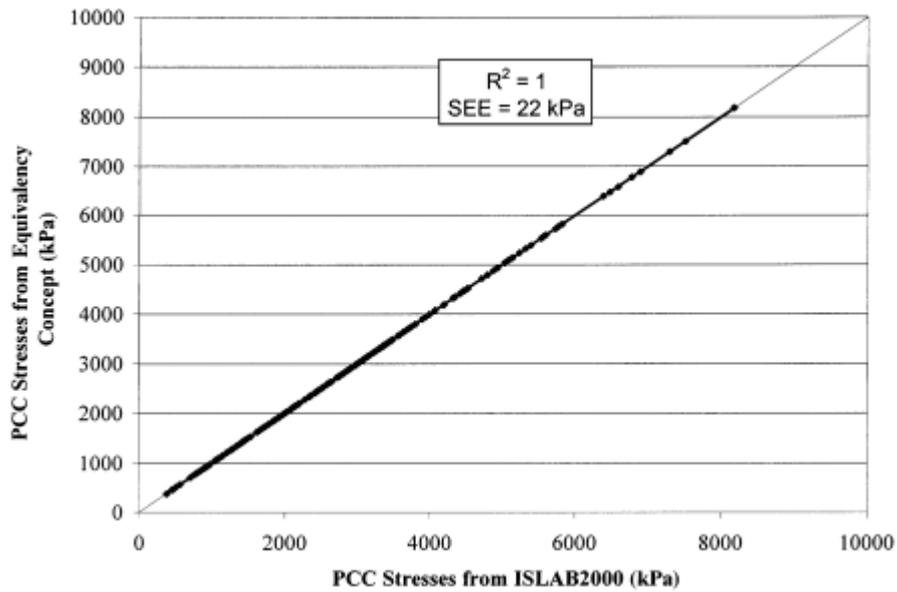
Figure 2. 37 – CRCP top surface stresses obtained from ISLAB2000 and by using equivalent structure concept (KHAZANOVICH *et al.*, 2001)

As Figure 2.37 shows, there is a perfect correlation of the equivalency model with simulations from ISLAB2000.

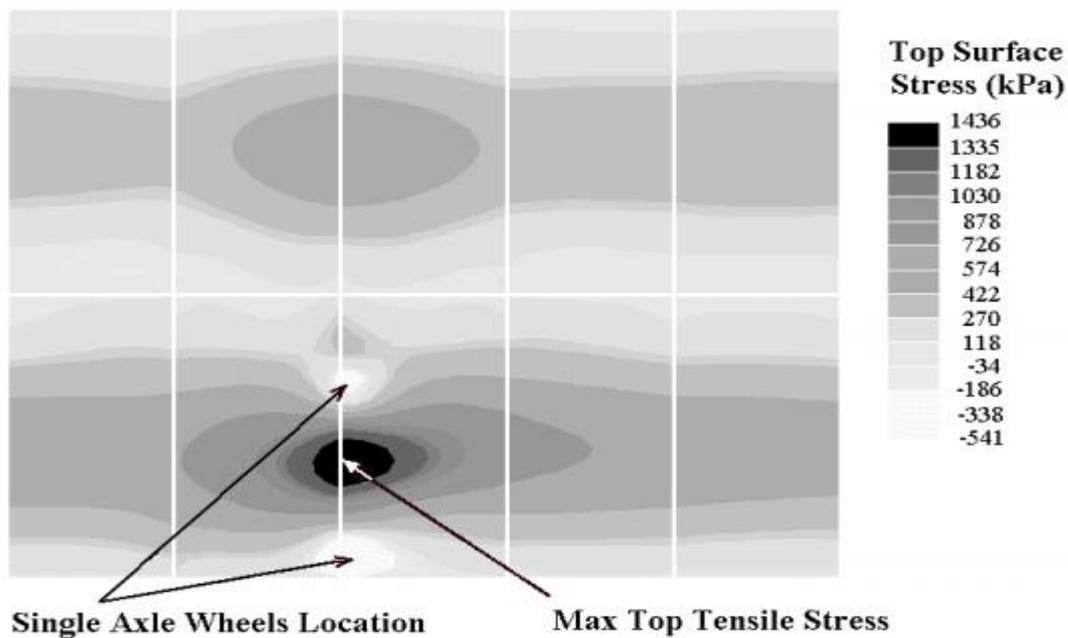
Figure 2.38 – Stress output example of mechanist model (SELEZNEVA *et al.*, 2004)

The simulation of a known load over a CRCP lane is illustrated in Figure 2.38. It can be seen that the location of maximum tensile stresses on the surface is in the middle of the load application points (axis). This, in a single lane, represents the distance of 1 to 1.4 m from the lane edge which thus confirms the distance to the vast majority of longitudinal fatigue cracks in punchouts, as reported by Selezneva *et al.* (2004).

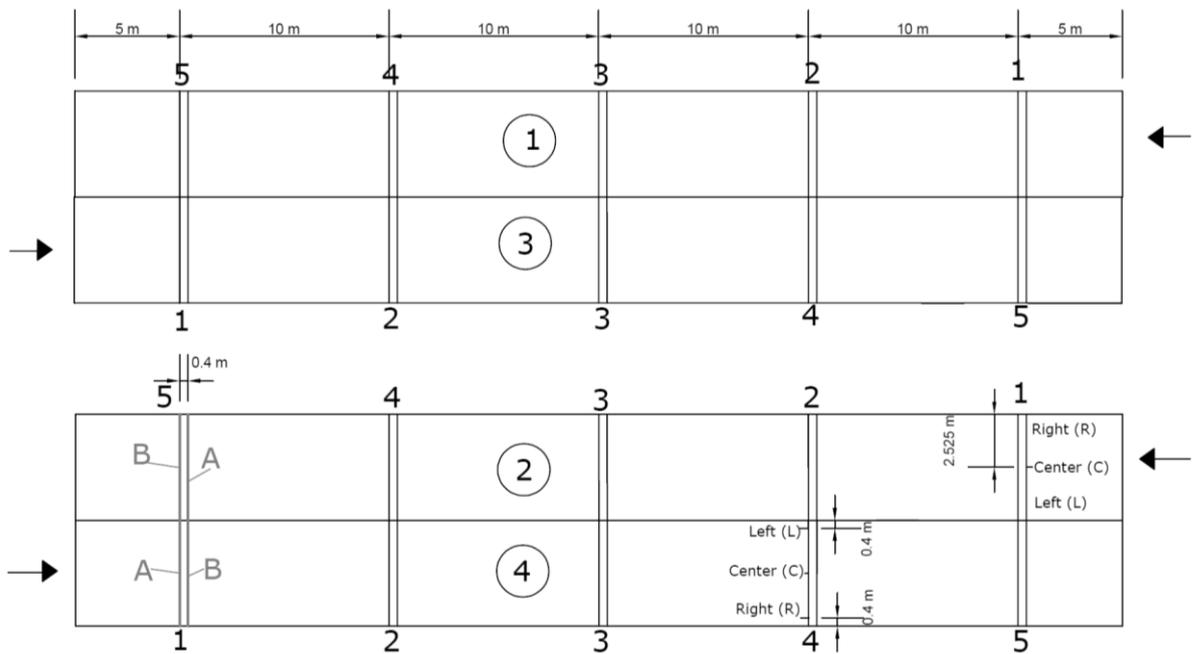
Figure 3.1 – Steel depth and location and slab thickness measuring stations

For steel characteristics and slab thickness the readings were made on five measuring stations per section. Stations were distanced 5 meters from the edge (stations 1 and 5) and 10 meters from each other (2, 3 and 4). At each station two lines of measurements (A and B) were drawn and at each line readings were made at the right (40 mm from longitudinal edge), center and left (40 mm from longitudinal joint) positions. Lines A and B were distanced at 40 mm to avoid placing the device above a transversal bar where it would be difficult to measure the slab thickness. The stations number and the position of the A and B lines were defined considering the traffic direction on each section (arrows in Figure 3.1). Firstly, readings were held in the transversal direction in order to find the longitudinal bars position, which then were marked on the pavement surface. Three readings were made for all locations moving the device (MIRA) 60 mm after each reading. Subsequently to this, the thickness was measured in between bars in the longitudinal direction. Three readings were made beginning at the MIRA center and moving it forward and back for the next two readings. Thickness measurements locations were marked with an X and a V for the measurements lines A and B, respectively. New calibrations were made whenever the measurement changed from steel depth and position to slab thickness. Calibration consisted of a measurement to determine the shear wave velocity at the slab surface in each location. It is recommended a new calibration for each new set of readings. Figure 3.1 displays the measurement stations and locations.

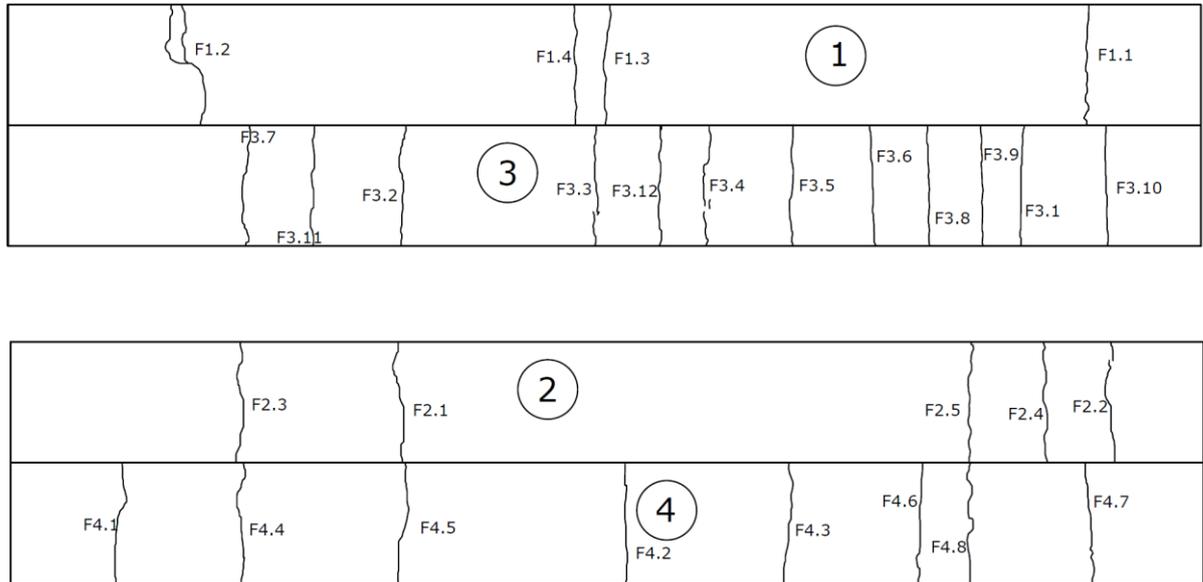
Figure 3. 2 – Short CRCP March, 2015 crack map

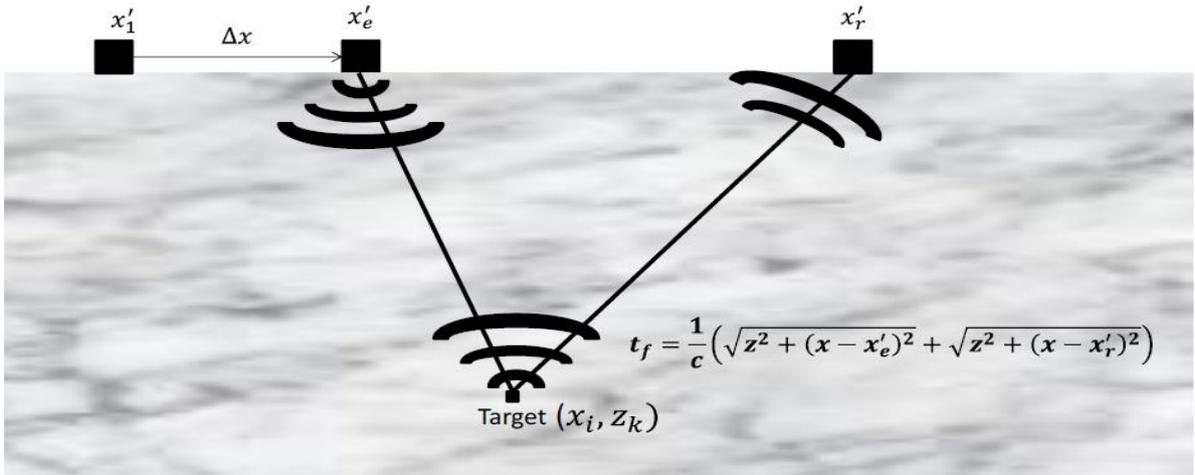
Figure 3. 3 – Illustration of MIRA linear array and signal time of flight equation (HOEGH and KHAZANOVICH, 2015)

Ultrasonic readings were processed using the technique for ultrasonic linear array evaluation developed by Hoegh (2013) where a much more detailed approach can be found. In brief, the ultrasonic time-history data provided by MIRA’s 45 transducers pairs at various incident angles was processed using an adaptation of the instantaneous amplitude-based synthetic aperture focusing technique (SAFT). The SAFT is applied in the MIRA software to provide 2D images of the readings; however the algorithm adaptations performed by Hoegh (2013) were able to improve the original images. The information received by transducers pairs at spatially diverse locations allowed for reconstruction of the relative reflectivity amplitude within the region of interest (ROI) creating a B-scan of the area by addressing a specific reflection color for each level of amplitude showed by the ultrasonic signal. For this, information on the time of flight of the signal emitted by a transducer, going through the target (reflection point) and being received by another transducer (Figure 3.3) and shear wave velocity for all transducers pairs were applied in Equations 52 and 53.

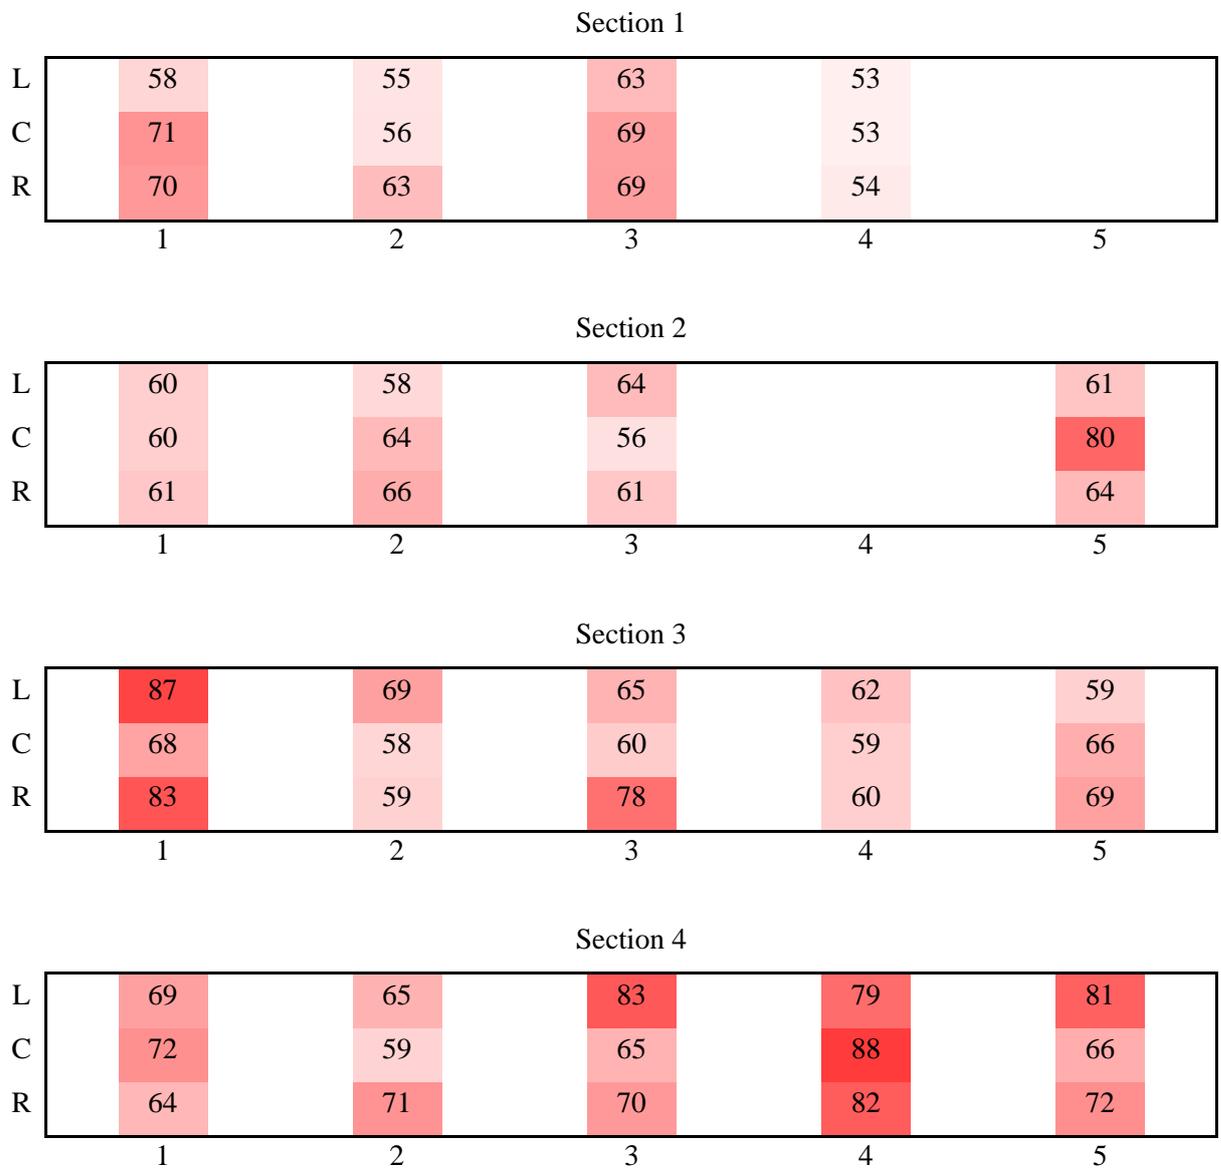
Figure 3. 14 – HTI color map

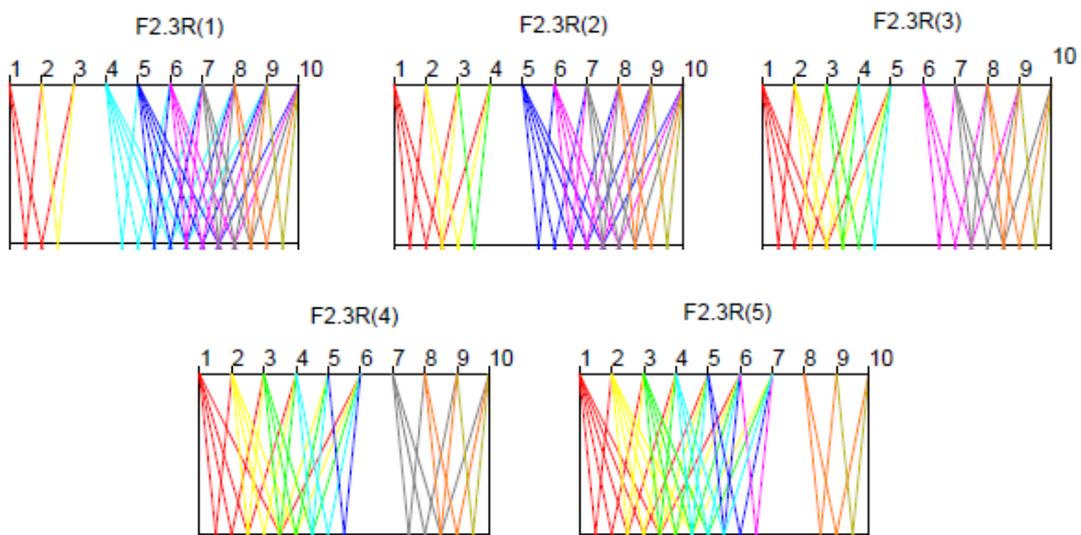
Figure 3. 28 – Simulation of crack F2.5-R scans based on HTI

presented in Figure 3.28. As can be seen, on the first scan the crack is positioned between sensors 3 and 4, and as the scans are moved the crack also change location accordingly to the predetermined 45 mm scan offset. Moreover, the simulation of the five scans proves that the crack is fully developed along the slab depth. It is also important to note that cracks are usually non-uniform and exhibit wandering shapes across the slab's depth. This helps to explain why this particular crack is positioned below sensor 3 and 4 and not below sensor 5 and 6 (MIRA's center).

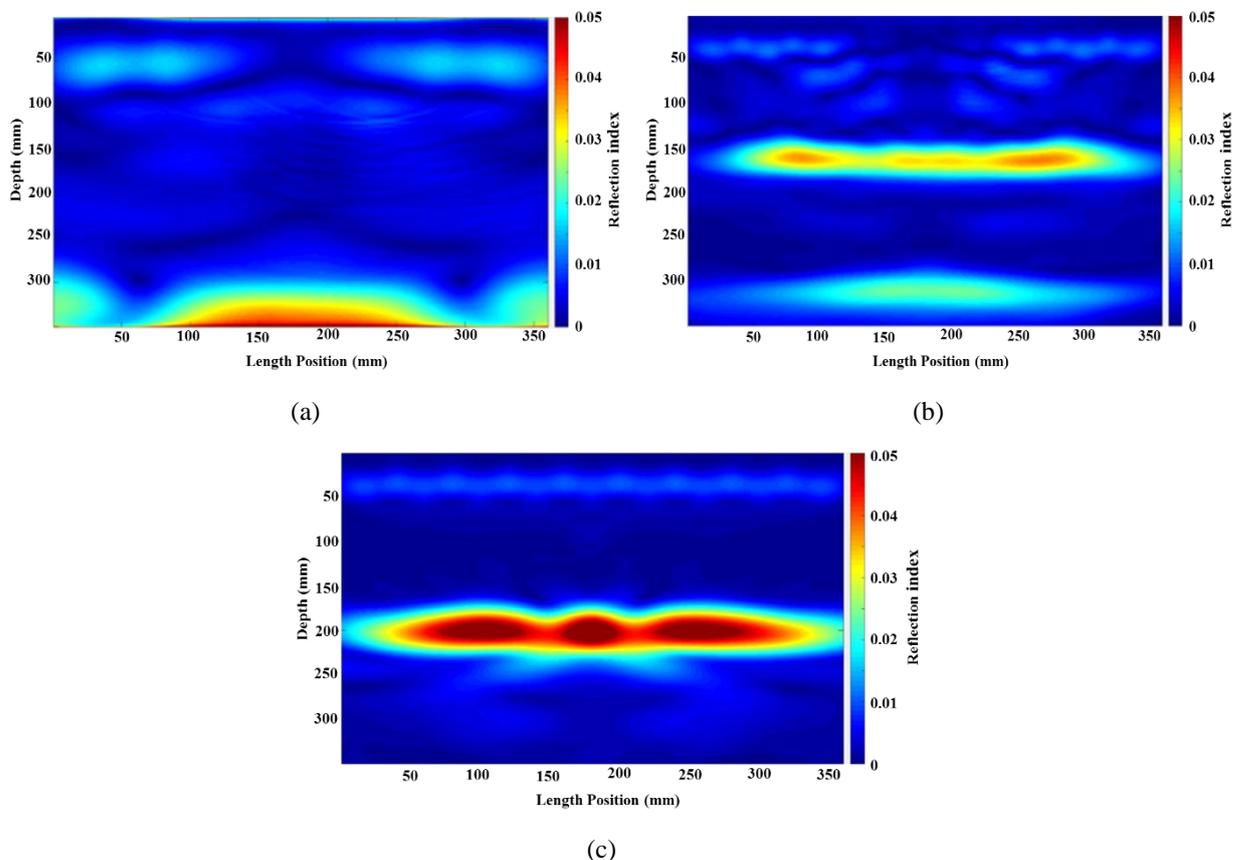
Figure 3.31 – Simulation of (a) Full crack, (b) Top-Down Crack and (c) Bottom-Up Crack

Simulation results are displayed in Figure 3.31. As can be seen, the simulated reconstructions were quite inconclusive. Simulations with a transversal bar showed the same results. There seems to be a backwall displacement for the full and TD cracks (simulated backwall was at 200 mm). The BU crack shows backwall reflection at the center of the reconstruction. HTI values were consistent with the analysis previously performed only for the full crack. The research team at the University of Minnesota currently works on updates to the simulation software

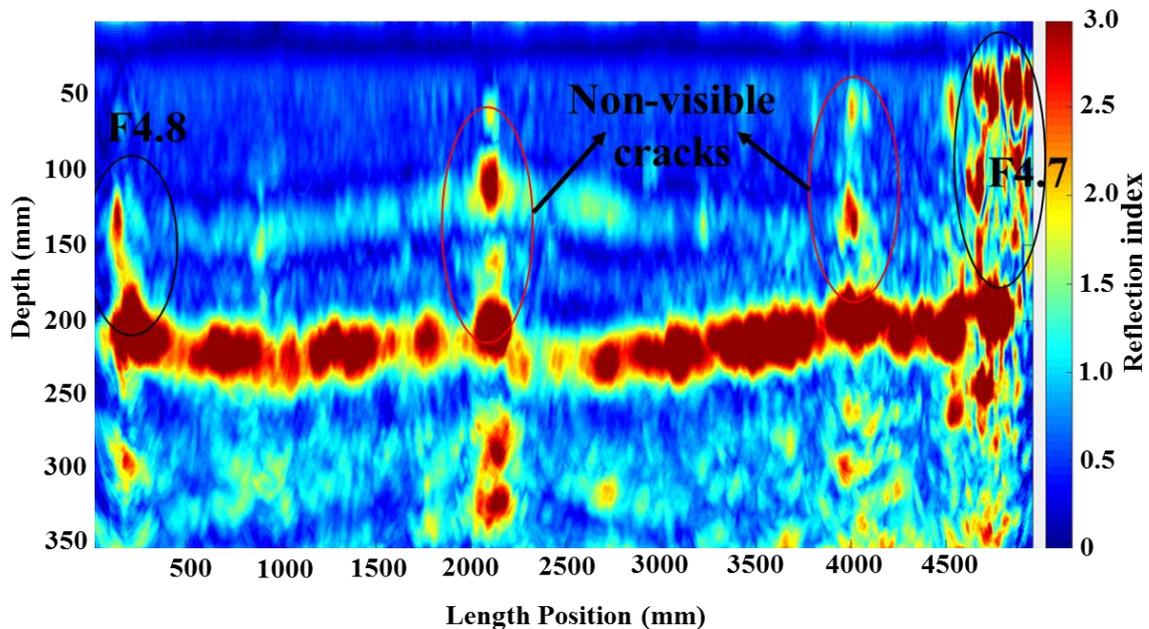
Figure 3. 32 – SAFT-Pan reconstruction of panel between cracks F4.8 and F4.7 in Section 4

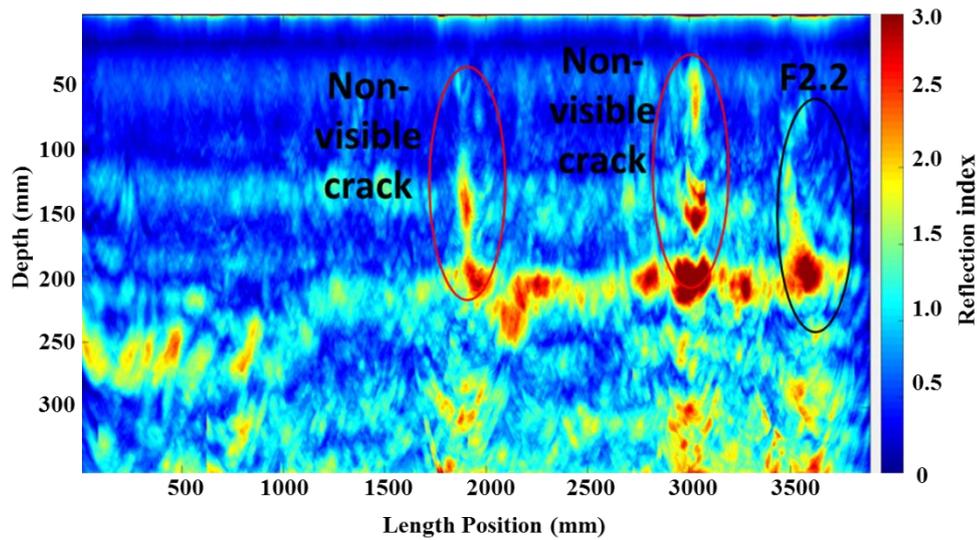
Figure 3. 33 – SAFT-Pan reconstruction of panel between Section 1 and F2.2 in Section 2

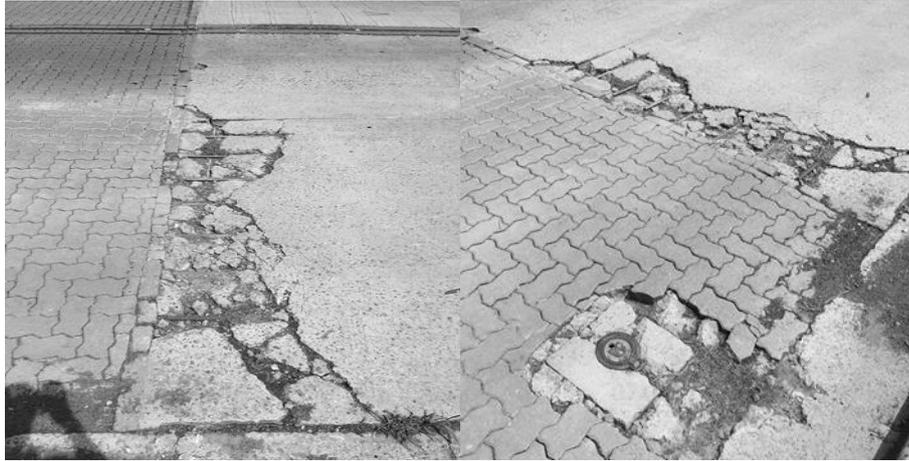
Figure 3. 38 - Distresses in the transition between interlock pavement and the short CRCP section 1

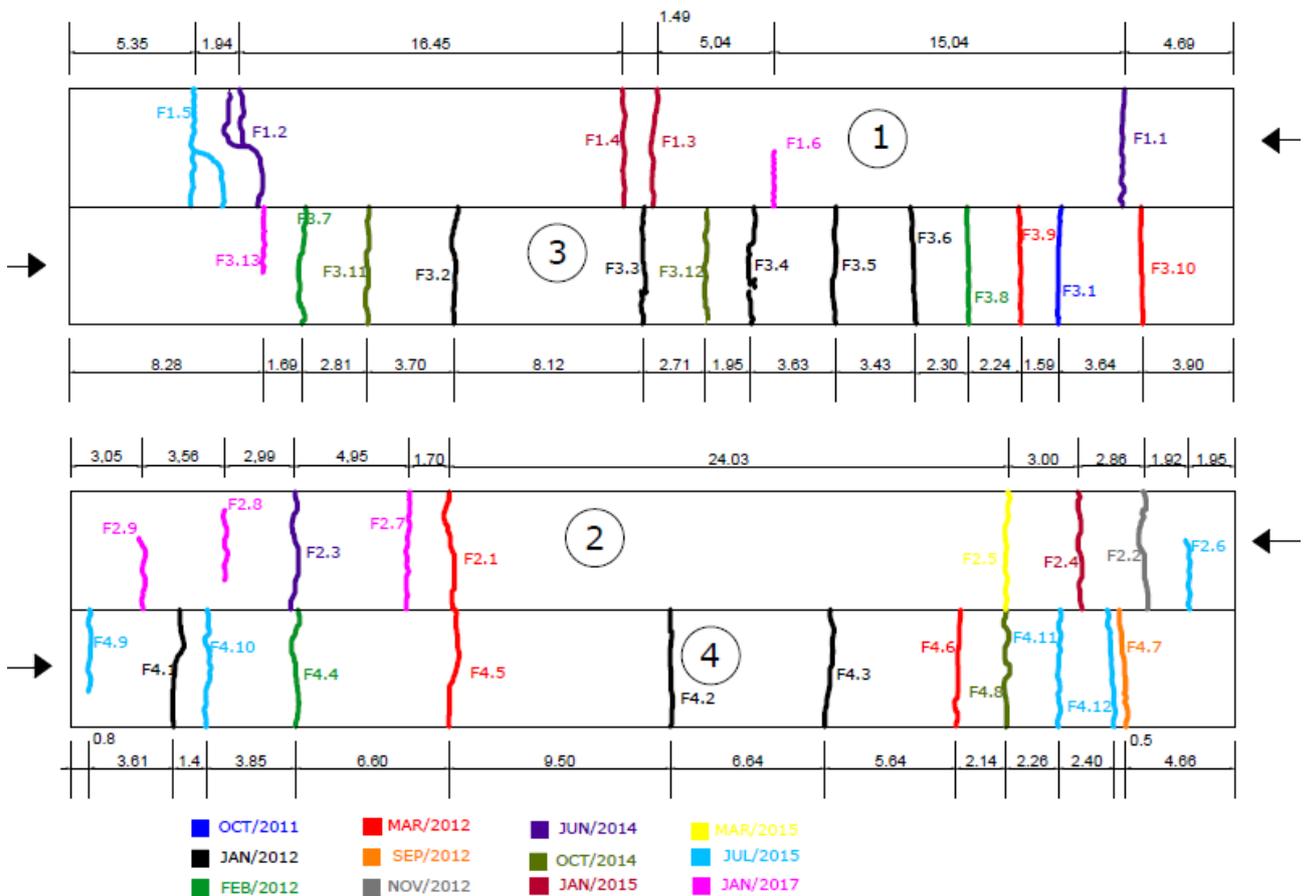
Figure 4. 1 – Updated crack map (June 2015)
