SHORT CONTINUOUSLY REINFORCED CONCRETE PAVEMENT  
DESIGN RECOMMENDATIONS BASED ON NON-DESTRUCTIVE  
ULTRASONIC DATA AND STRESS SIMULATION

Thesis submitted to the Polytechnic School of  
the University of São Paulo in partial  
fulfillment of the requirements for the degree  
of Doctor of Science in Engineering

Concentration field: Transportation  
Engineering

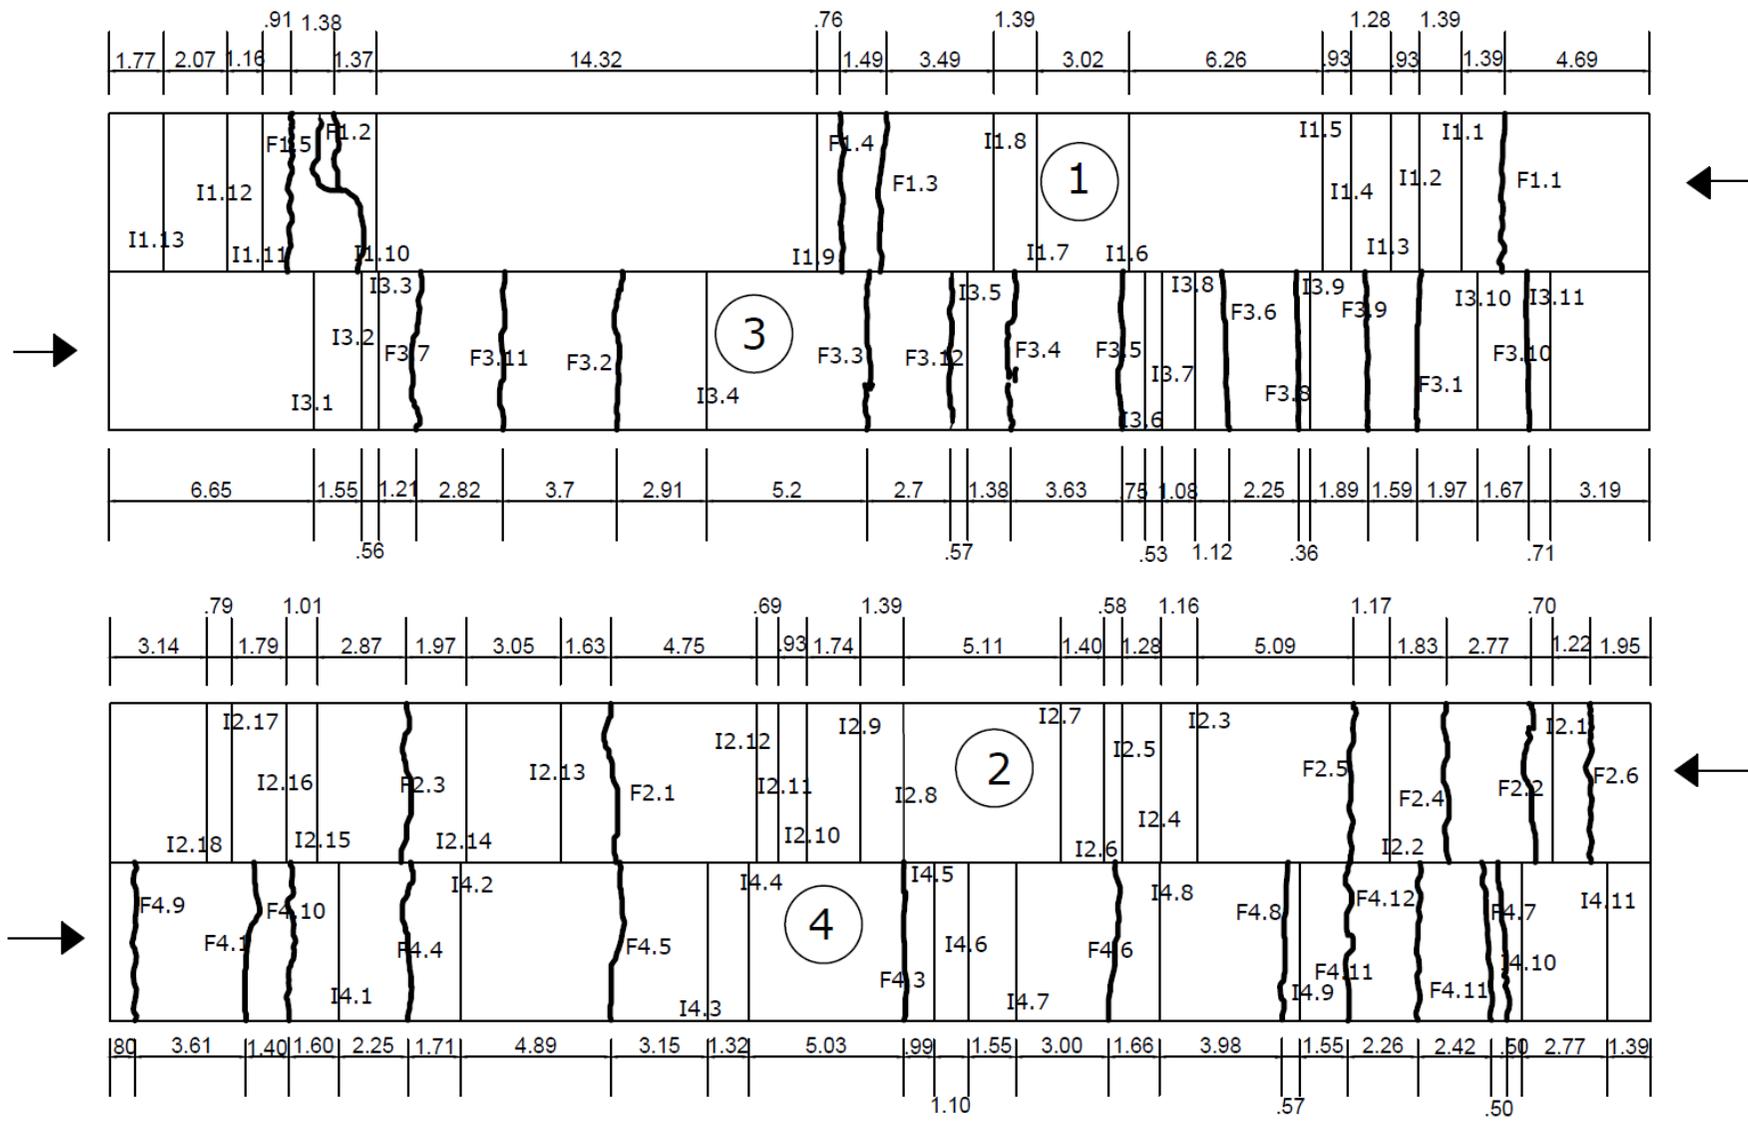
Figure 4.5– Crack map with visible and non-visible cracks

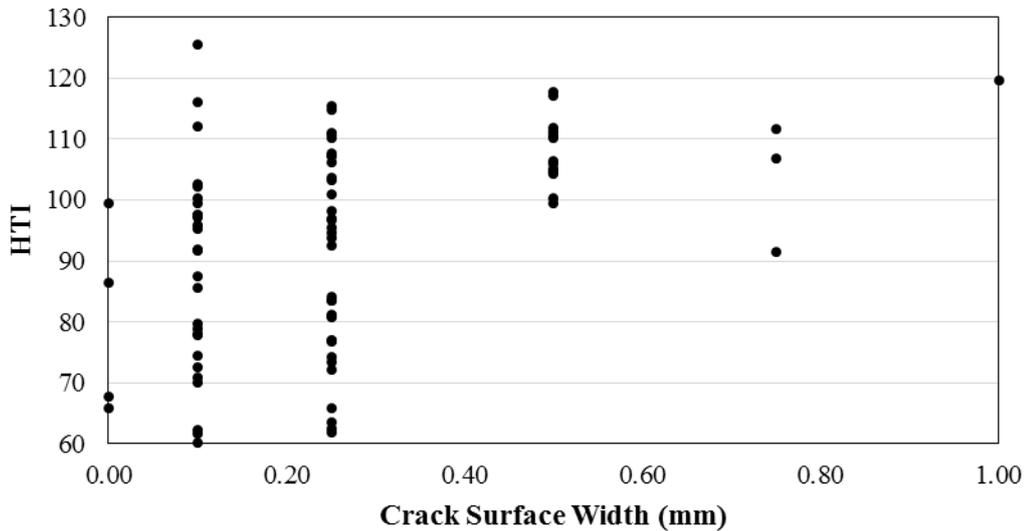
Figure 4. 9 – HTI versus surface crack width

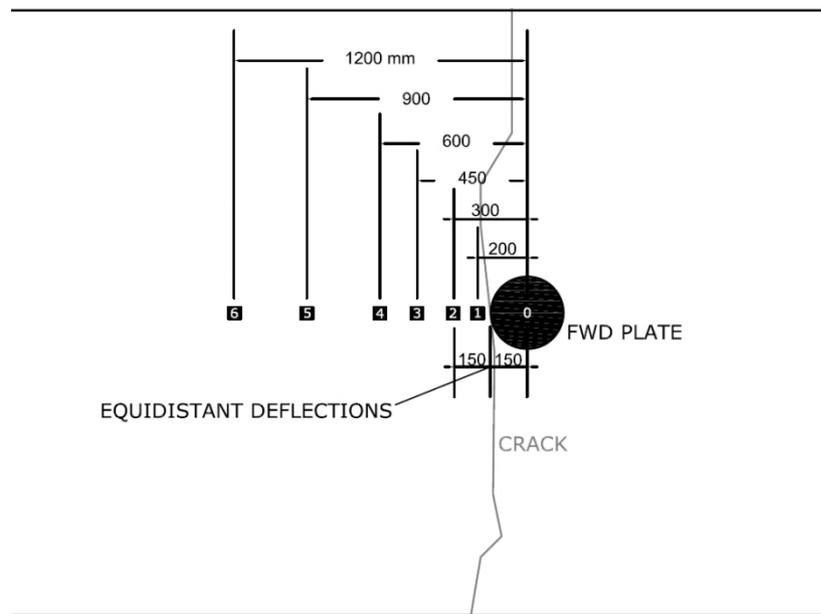
Figure 4. 10 – Illustration of FWD position to evaluate crack LTE

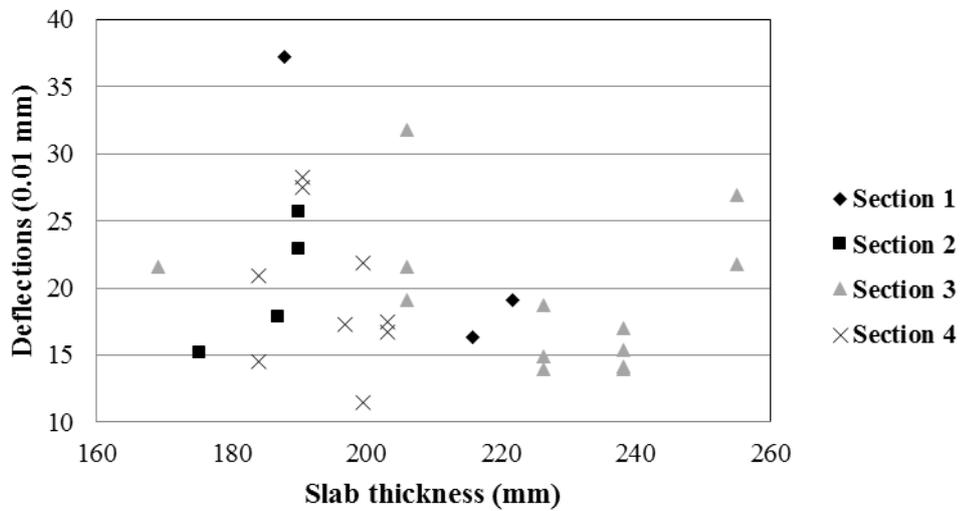
Figure 4. 18 – FWD testing maximum deflection versus ultrasonic testing slab thickness

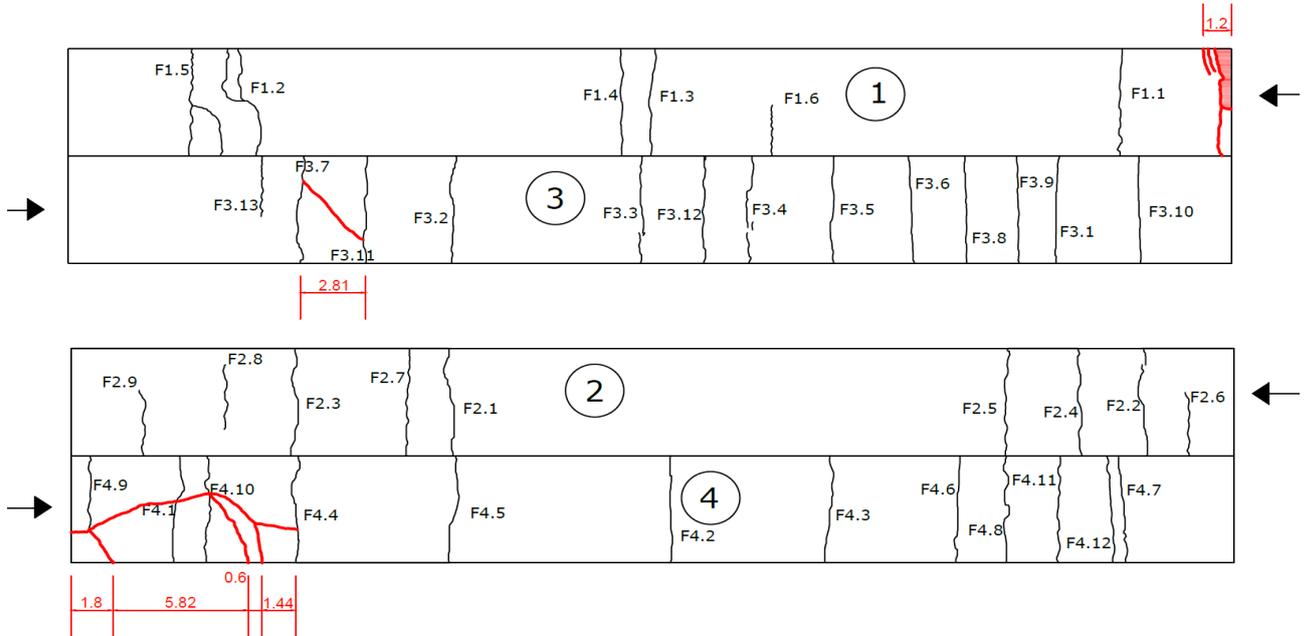
Figure 4. 21 – Cracking distresses visible at the short CRCP surface

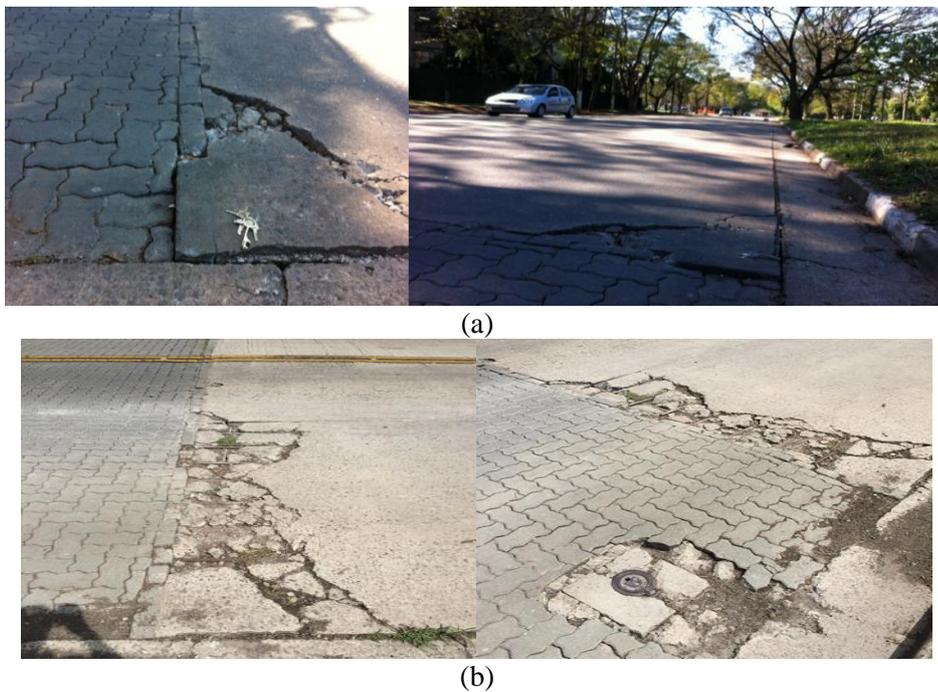
Figure 4. 22 – Cracking distress in section 1 in (a) 2013 and (b) 2017

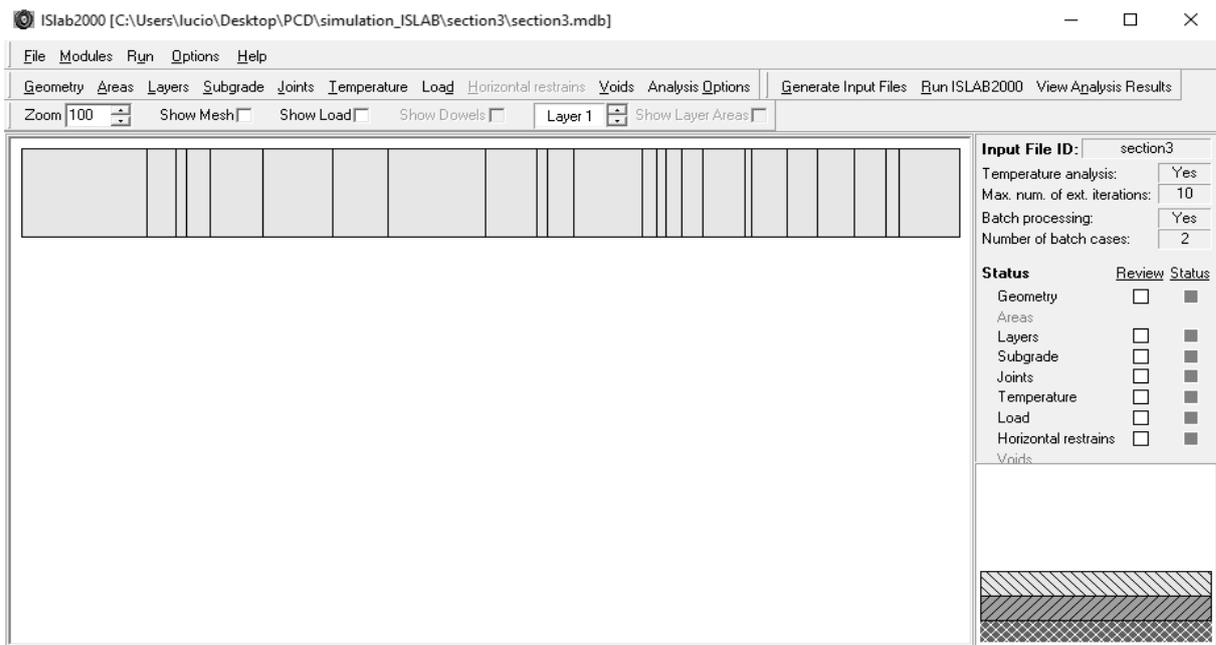
Figure 5. 3 – ISLAB simulation of section 3

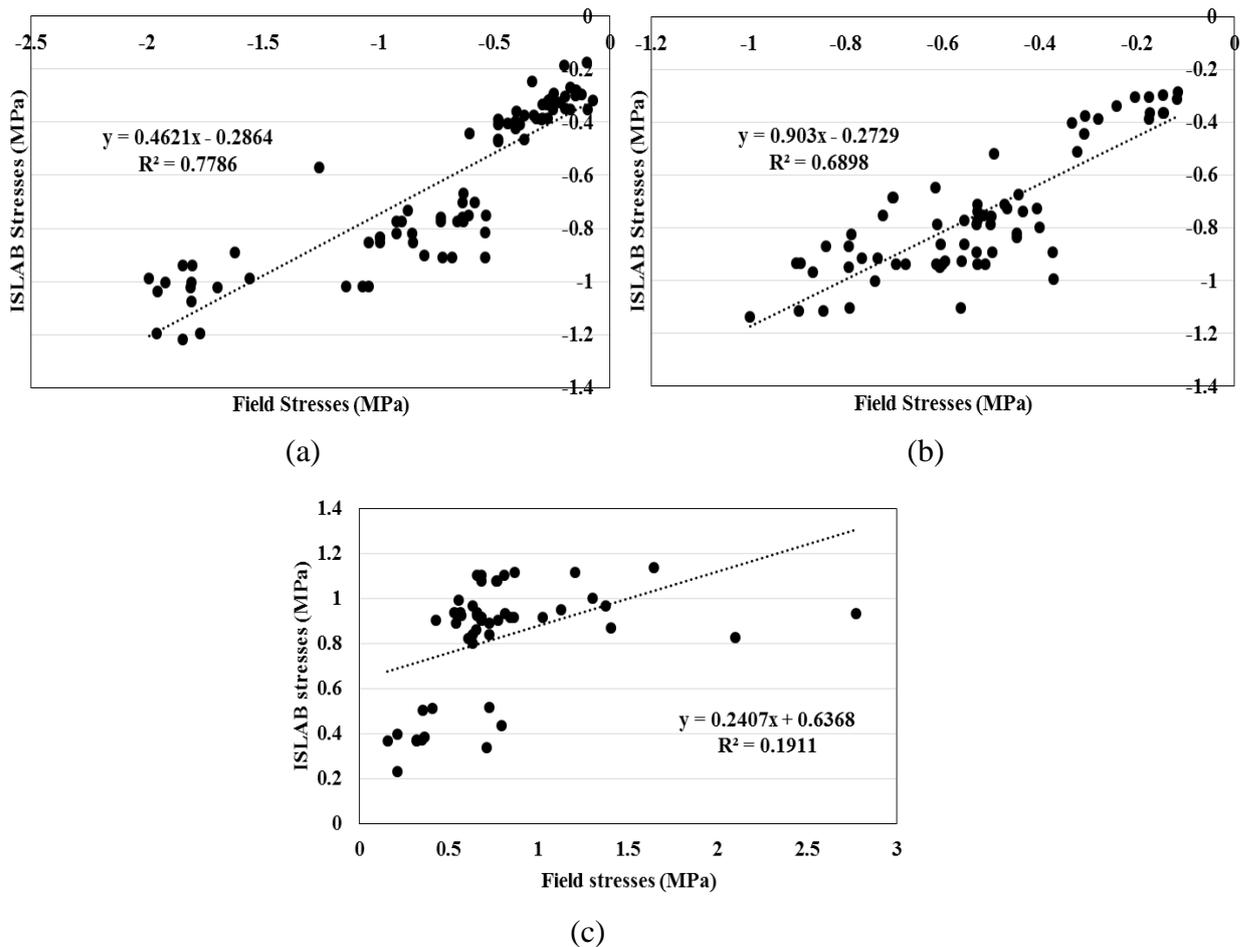
Figure 5. 8 – Correlation between field and ISLAB stresses for (a) surface, (b) top and (c) bottom SGs

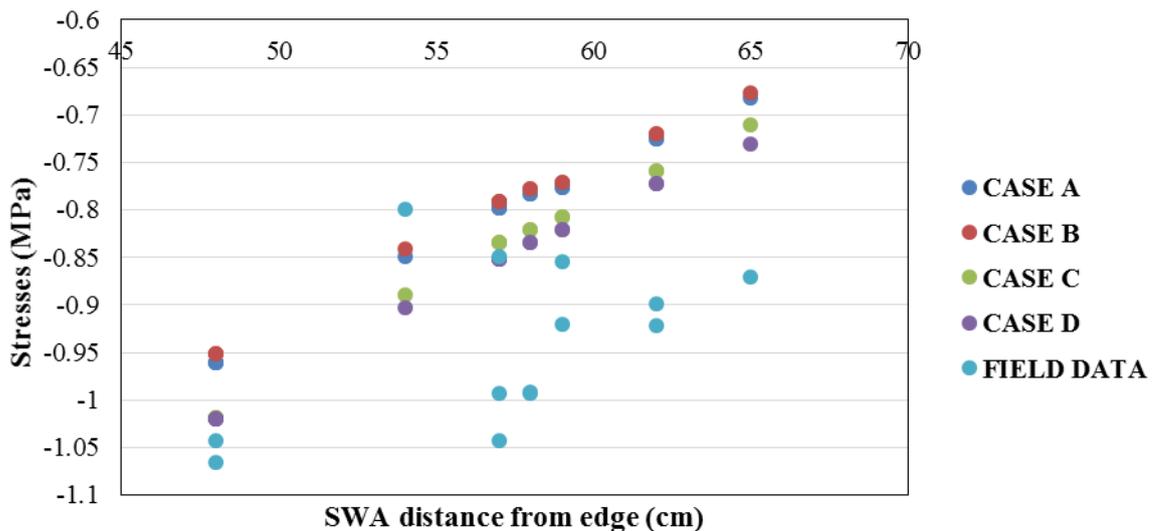
Figure 5. 11 – Simulation of constant thickness 212.98 mm slab (Case A); 215 mm slab (Case B); slab with thickness variation (Case C); and 215 mm slab with thermal gradient (case D)

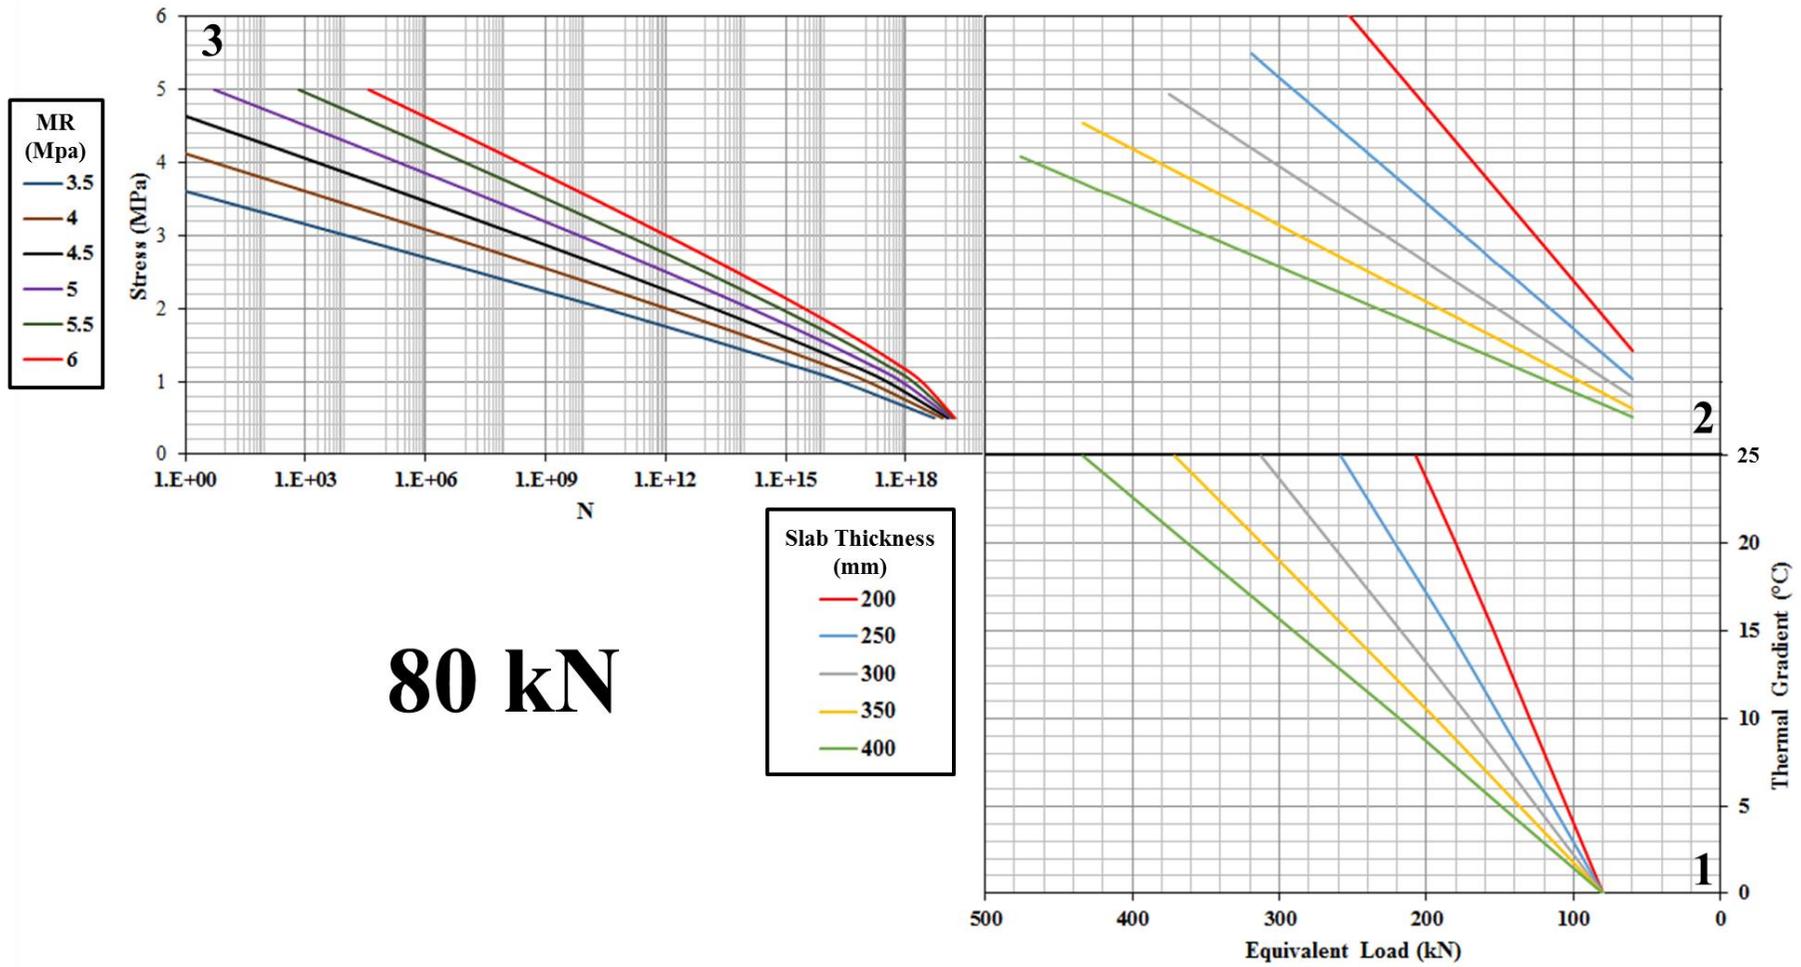
Figure 6. 13 – Short CRCP design chart for a 80 kN axle load
