**ANALYSIS OF THE MICROSTRUCTURE TRANSFORMATION (WEL
FORMATION) IN PEARLITIC STEEL USED IN RELEVANT
ENGINEERING WEAR SYSTEMS**

This thesis is submitted for the degree of Doctor
in science at the University of São Paulo.

Tese (Doutorado) - Escola Politécnica da Universidade de São Paulo,
Departamento de Engenharia Mecânica.

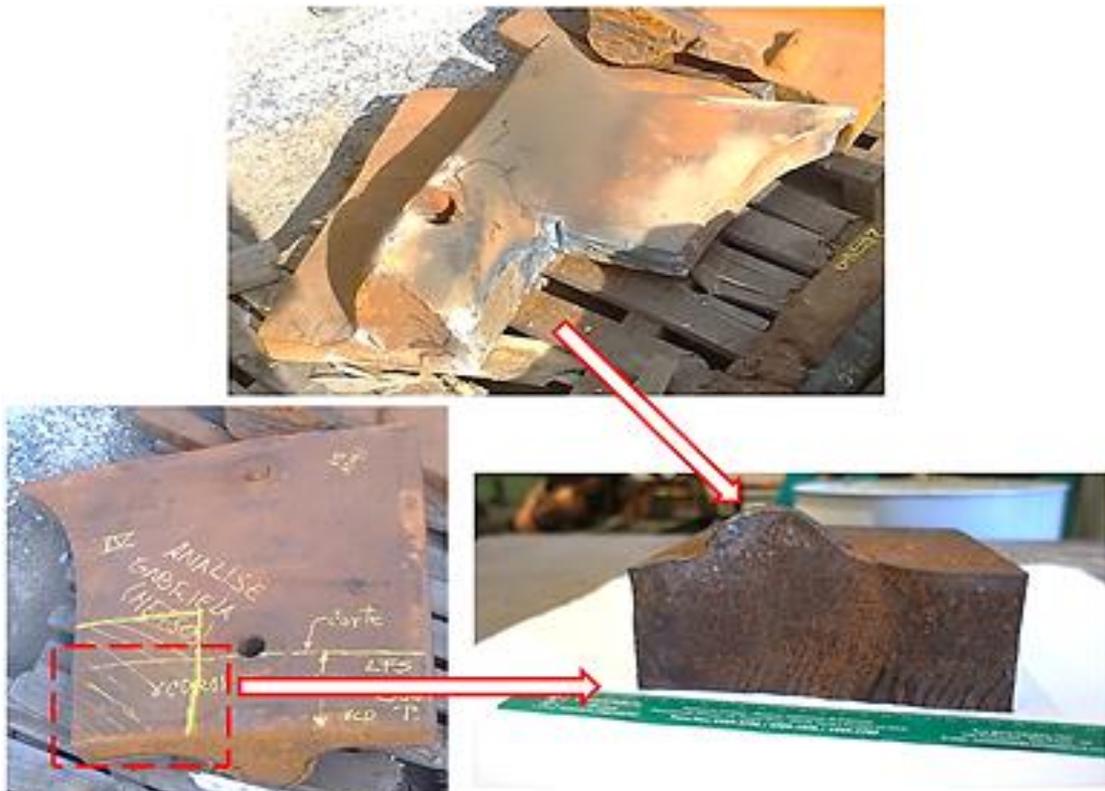
Figure 2-1 Procedure to obtain the sample of the SAG mill liner

All the samples used in this work were obtained from a Semi-Autogenous Grinding mill - SAG used in ore comminution (copper ore). Pearlitic steel (0.75 %C, 2.00 %Cr, 0.76 %Mn, 0.76 %Si) was analyzed. **Figure 2-1** shows the SAG mill liner used for the samples preparation. All samples analyzed in laboratory tests were prepared following the procedure:

- The cutting of the samples was carried out using cutting machine *Discotom-65*[®] fabricated by Struers[®].
- Metallographic polishing
 - Subsequently, the samples were mounted with Phenolic conductive resin;
 - Grinding with sandpaper (# 220 SiC) in the first step of the samples polishing. A sequence of polishing cloths was used following steps. It was used diamond paste with abrasive size from 10 μm up to 1 μm .
 - The microstructure was revealed using 5% Nital reagent (2 ml de HNO₃ in 98 ml de ethyl alcohol).

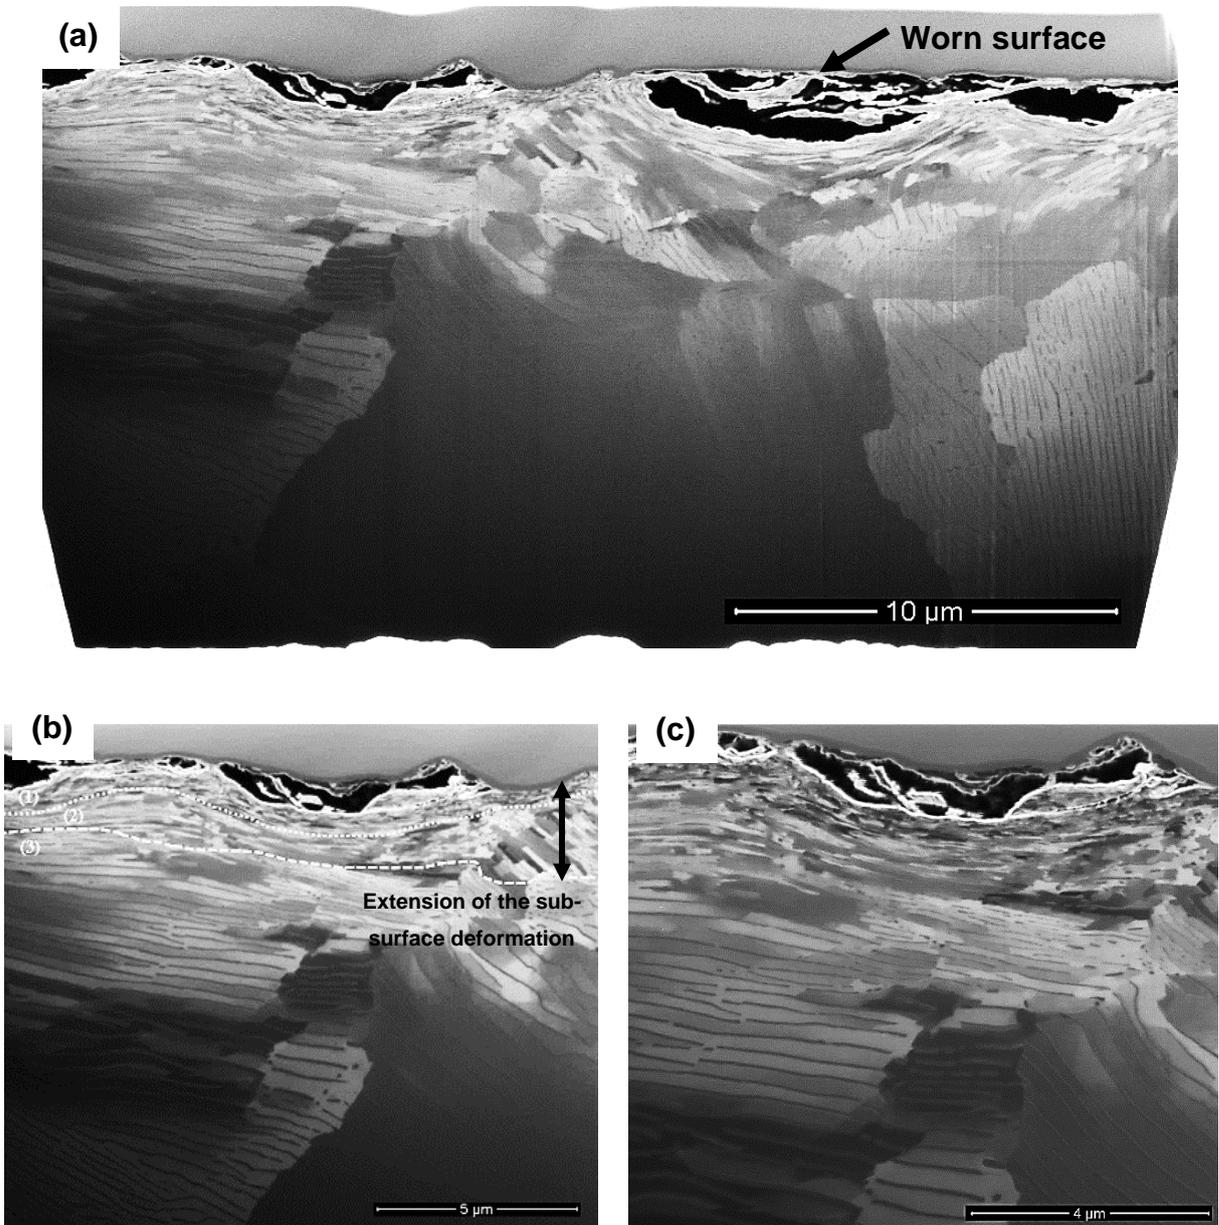
Figure 2-11 FIB-SEM images of wear central zone for the samples tested at 130 N in DSRW, a) general cross section view, showing the presence of an irregular surface, b) highlighted region with the two-deformed layer and c) image with higher magnification (30000x)

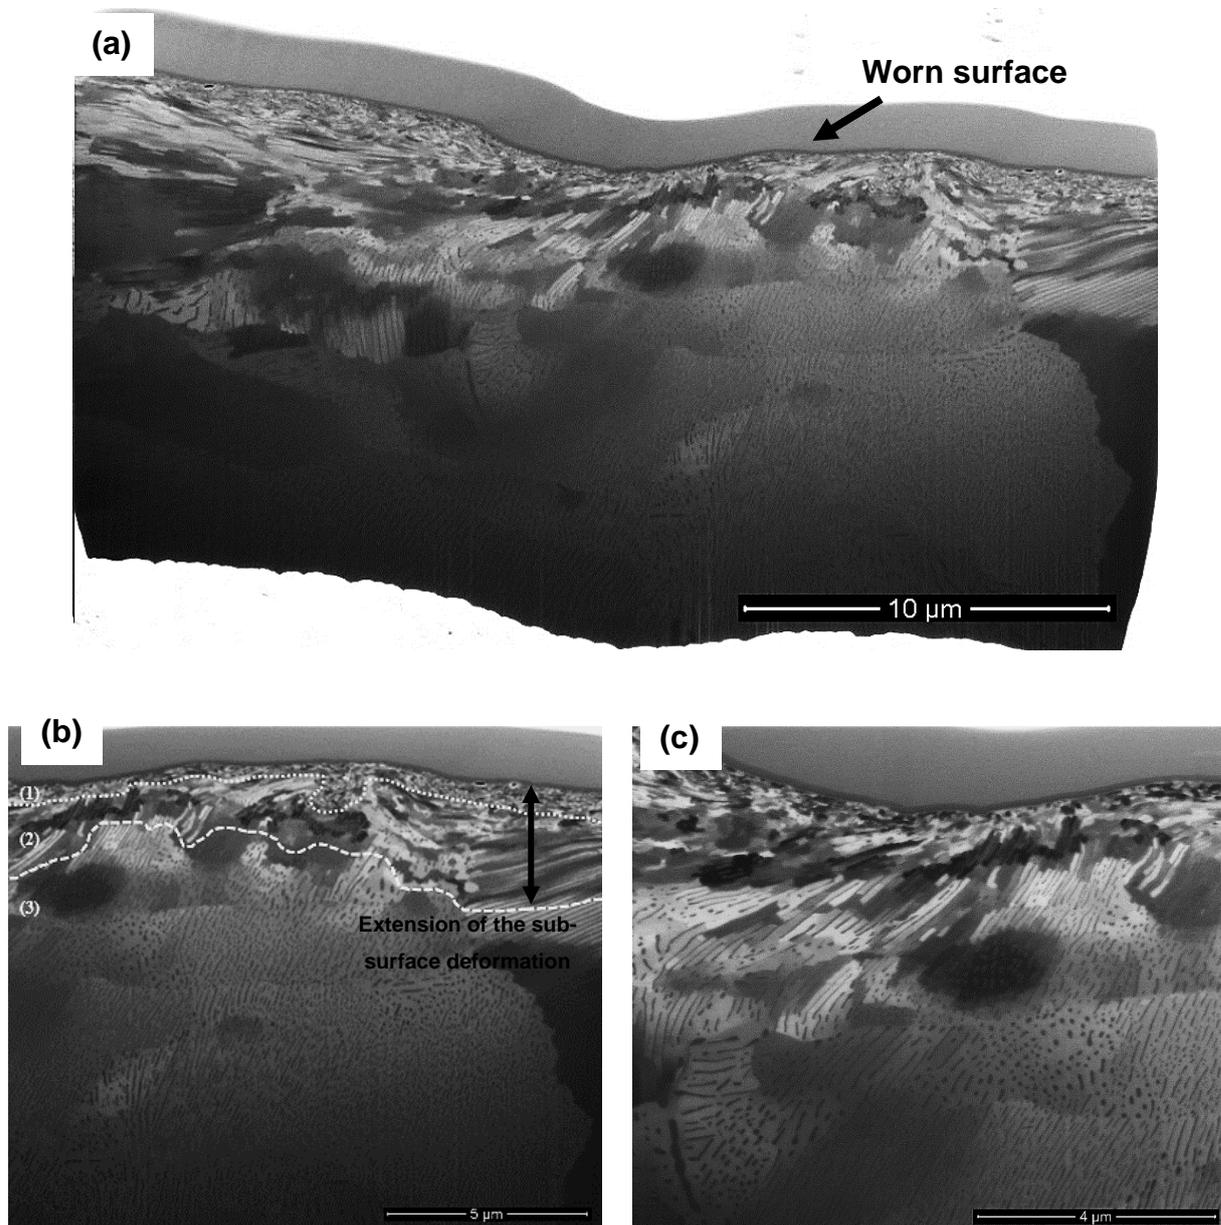
Figure 2-12 FIB-SEM images of wear central zone for the samples tested at 380 N in DSRW. a) general cross section view, b) highlighted region out of groove showing the two-deformed layer and c) image below the groove caused by an abrasive particle

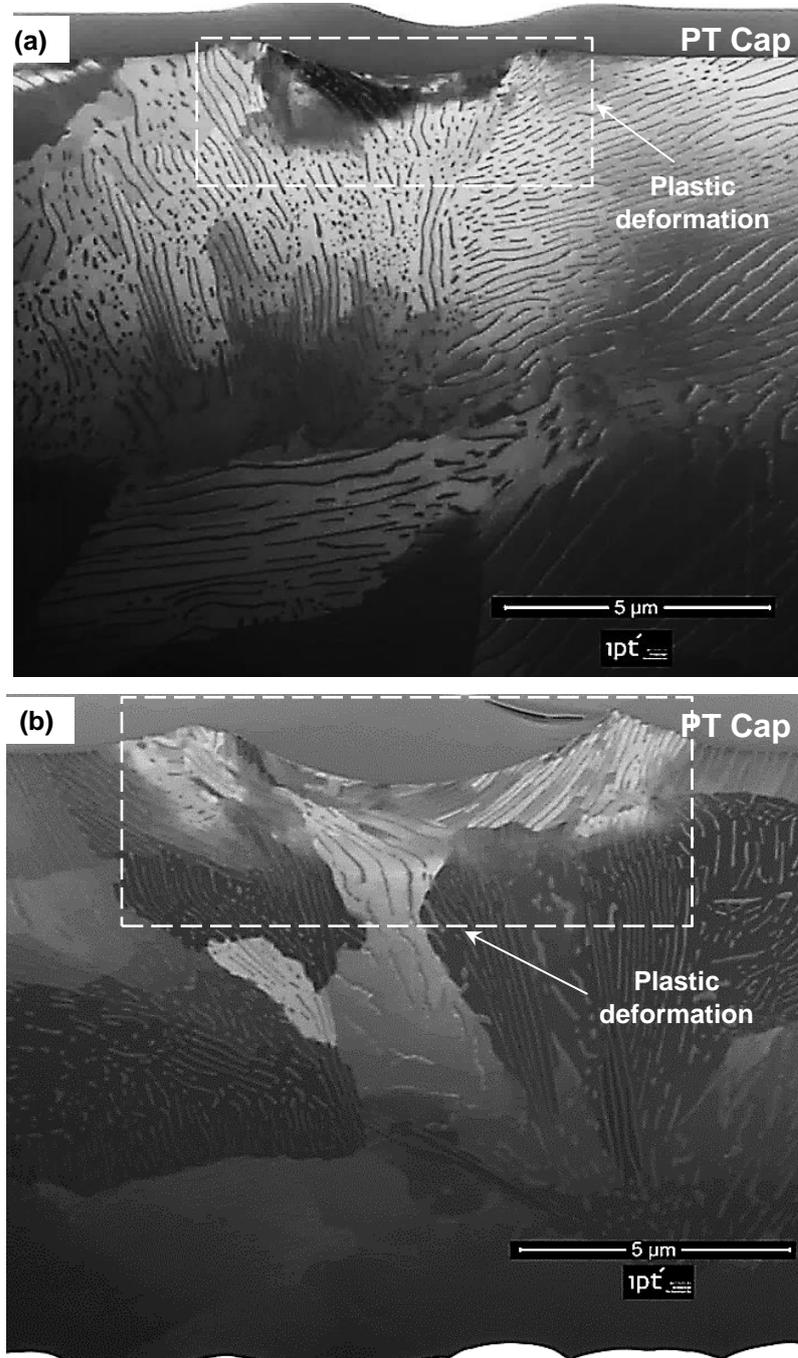
Figure 3-9 shows the microstructure of samples under the test surface after the scratch test at one-pass and five-passes. The typical pearlitic arrangement with a fine

Plastic deformation was observed in both conditions, being clearer in the sample tested at five-passes scratch (**Figure 3-9b**). Furthermore, this sample exhibited the formation of lateral deformation (pile up). None of the samples (even at intermediate conditions

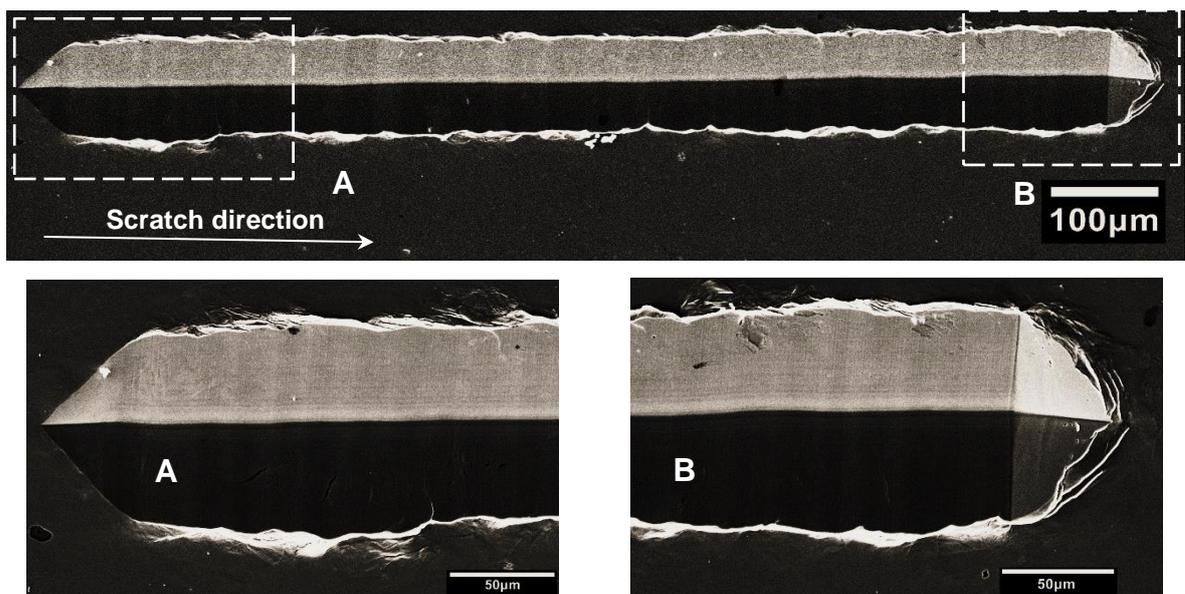
The grooves of samples tested at 8 N of normal load, one-pass and five-passes scratch sequences are shown in **Figure 3-12** and **Figure 3-13**, respectively. The increase in the geometrical dimensions (width, depth and distance between the piles up) with the increment of number of passes was measured. Material detachment was observed in the groove in the sample tested with the five-passes sequence evidenced in the highlighted images.

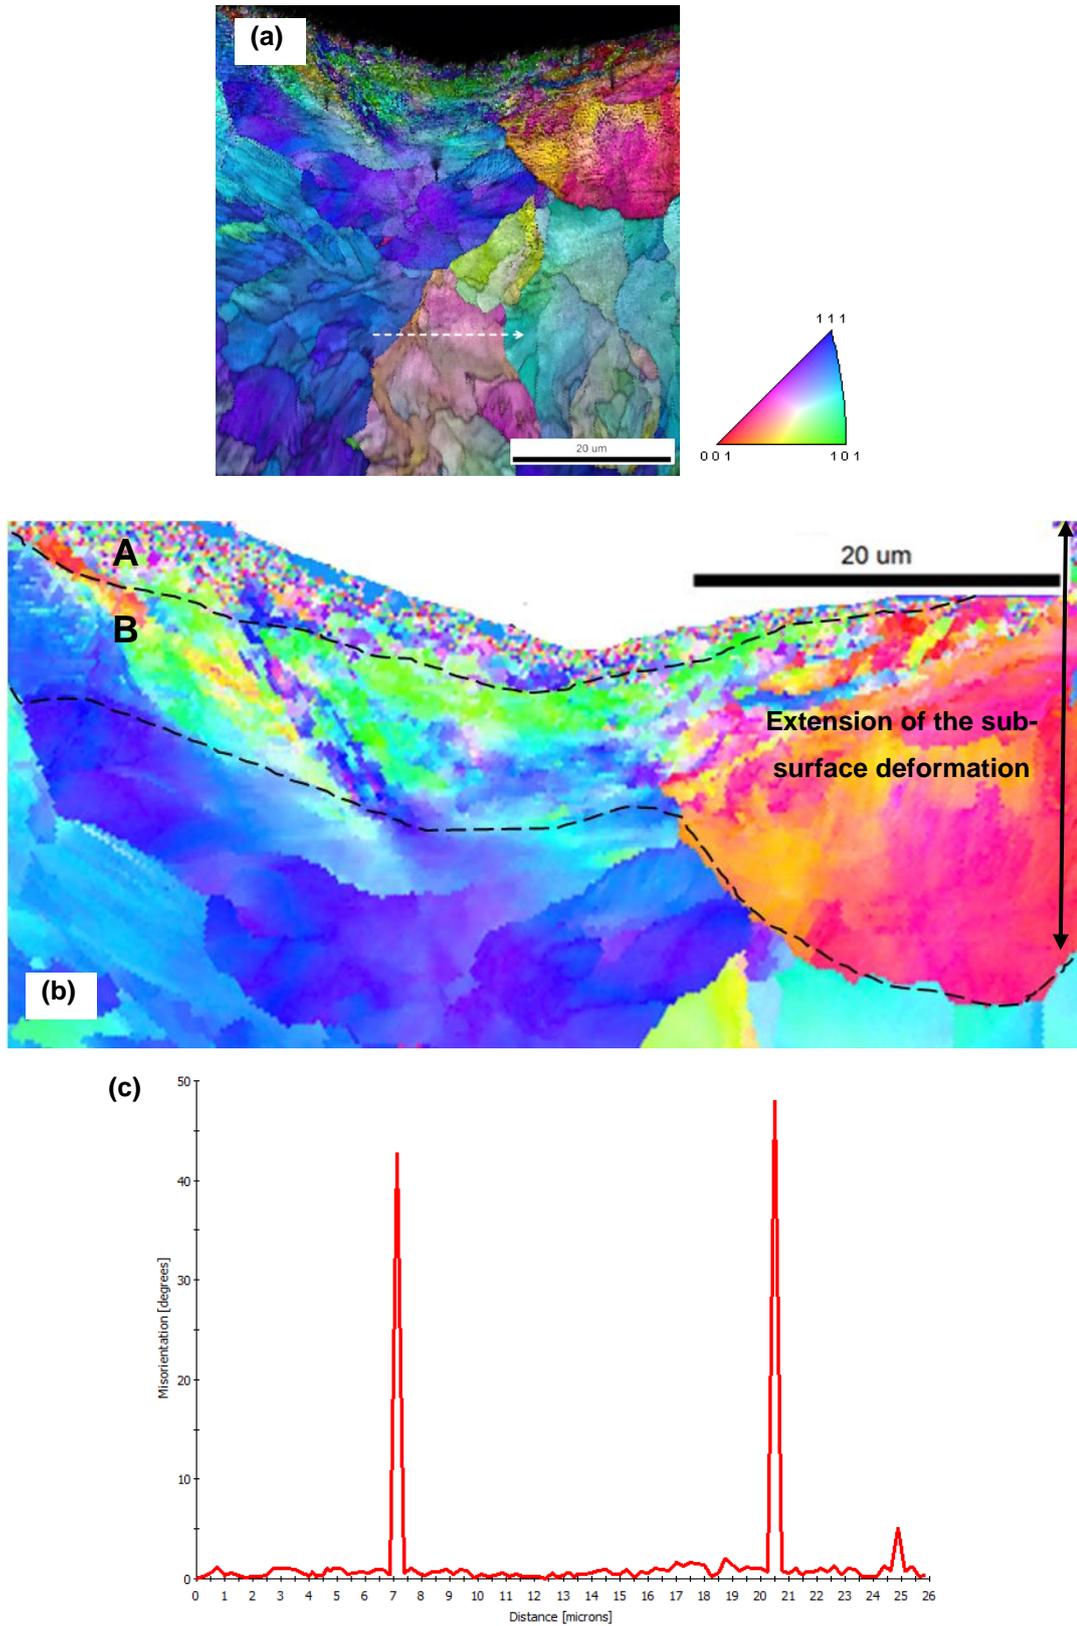
Figure 3-24 shows the IPF map in a sample tested with 4 N (normal load) and single-pass scratch sequence. The color distribution in the IPF map shows pearlite colonies mainly oriented in RD // $\{111\}$. It was identified two regions below the groove (indenter

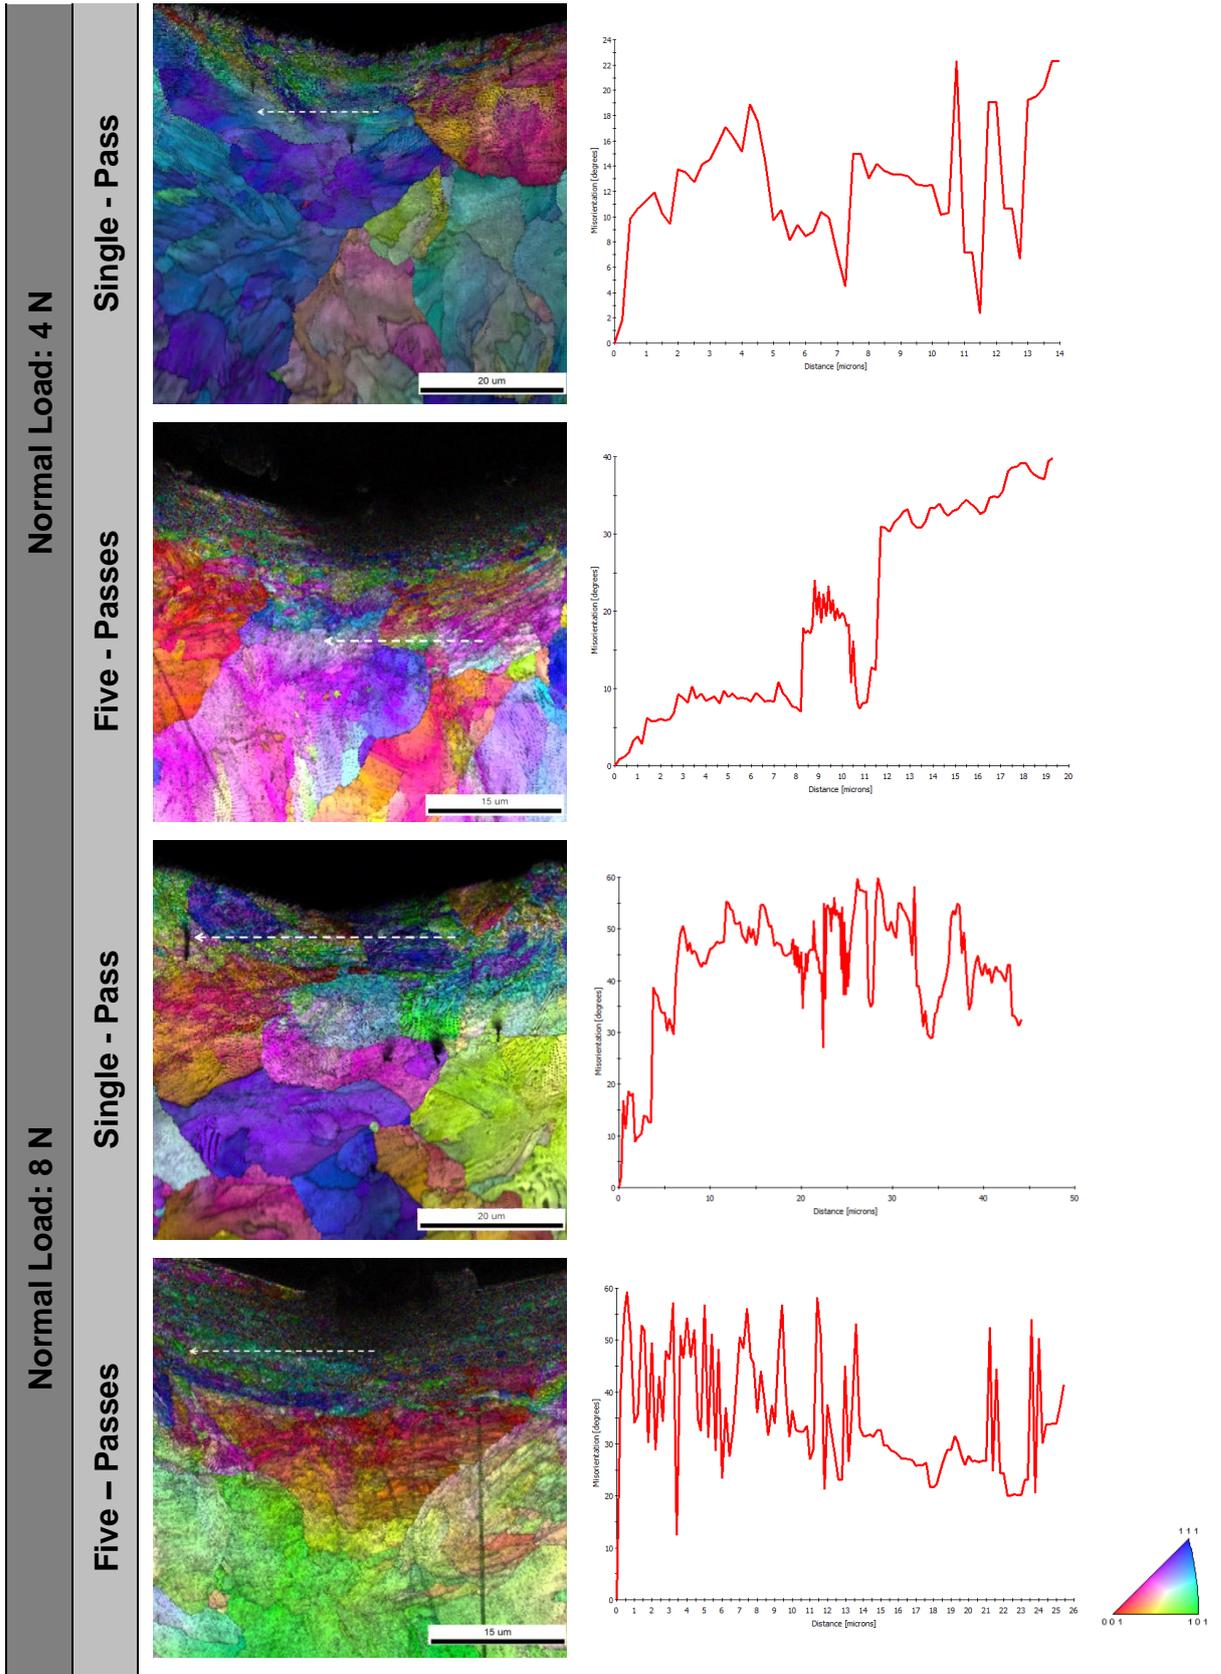
Figure 3-25 shows the IPF maps for samples tested in sequences of one-pass and five-passes scratch and normal loads of 4 N and 8 N. The analysis of misorientation shows HAGBs (higher than 15°) in all samples indicated by the black arrows. The analysis was performed in the region near the groove. High angle orientations were observed for all samples in the deformed layer, indicating that in those regions new grains (or colonies) were formed with a random orientation.

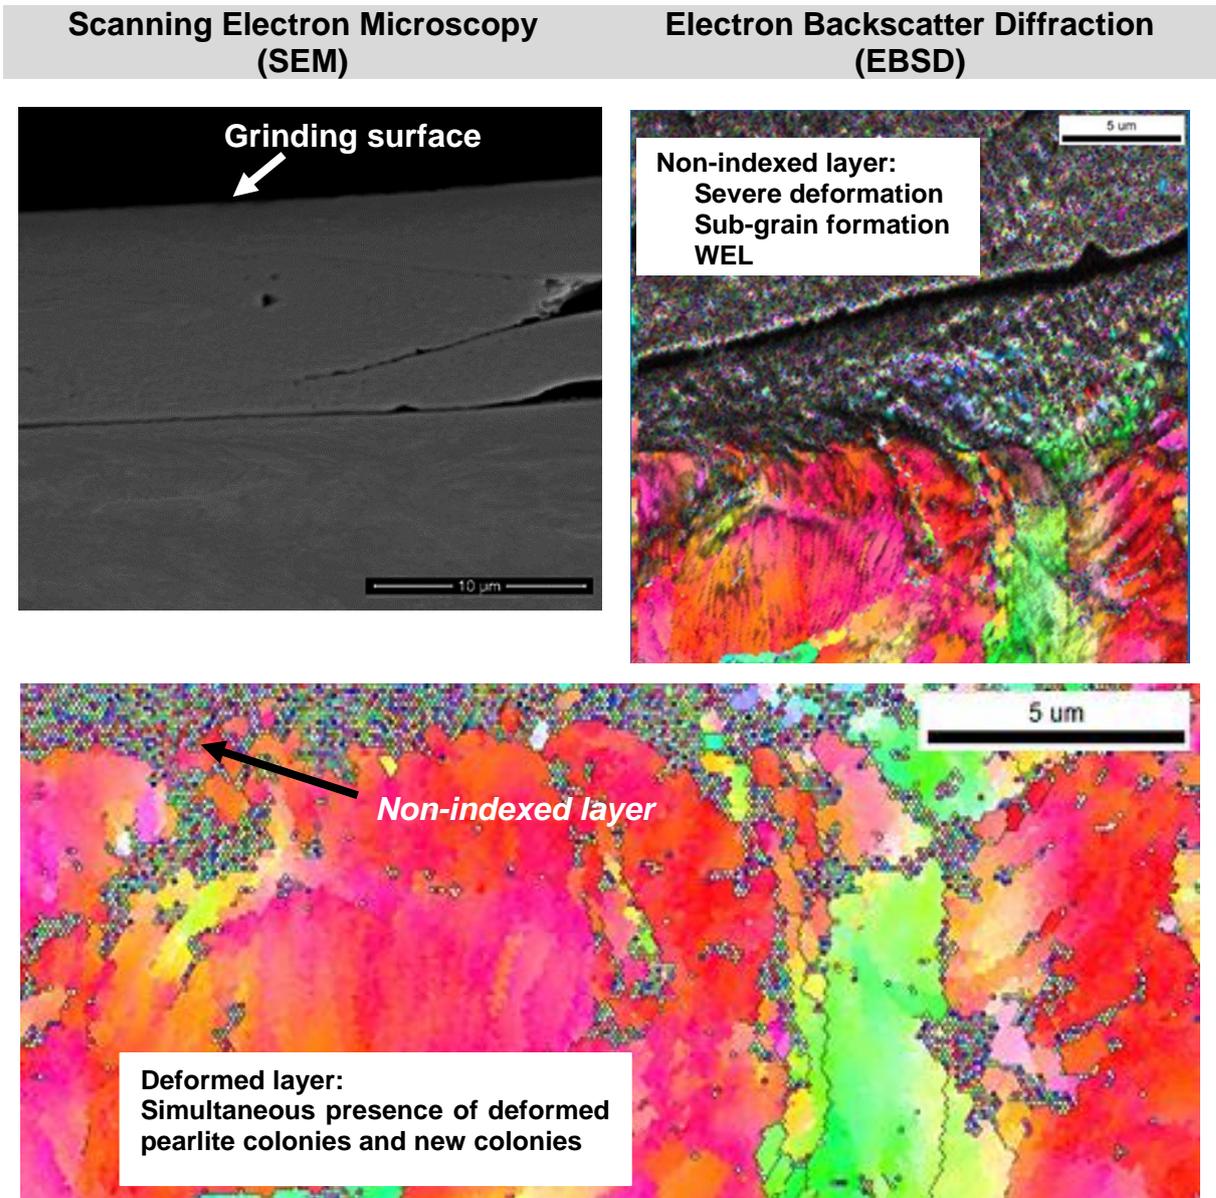
Figure 3-43. EBSD micrographs of the facet B of the sample taken from the rail under the first grinding condition

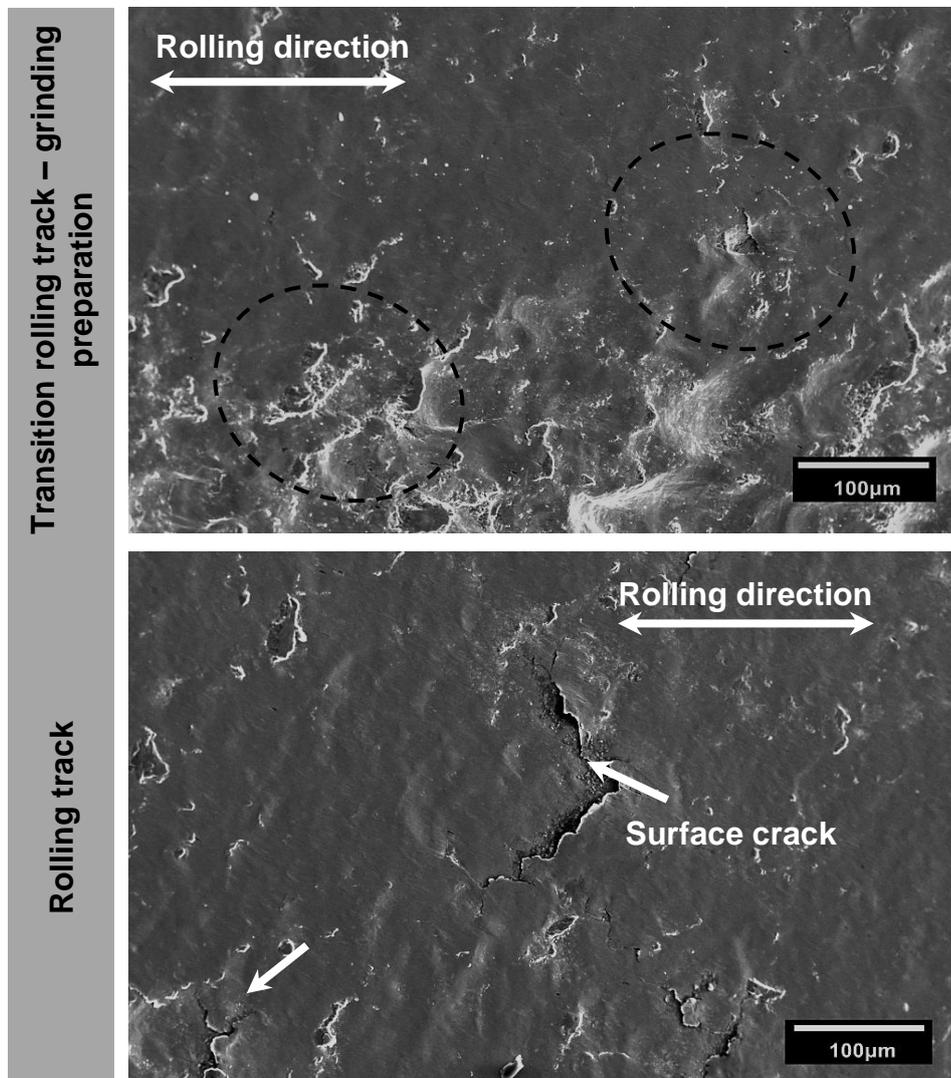
Figure 4-6 shows the surface of the W9 tested in the regions of the interface to rolling track and the grinding surface (sample preparation) and the rolling track. The formation of superficial fatigue cracks was identified, which promotes the spalling (RCF defect).

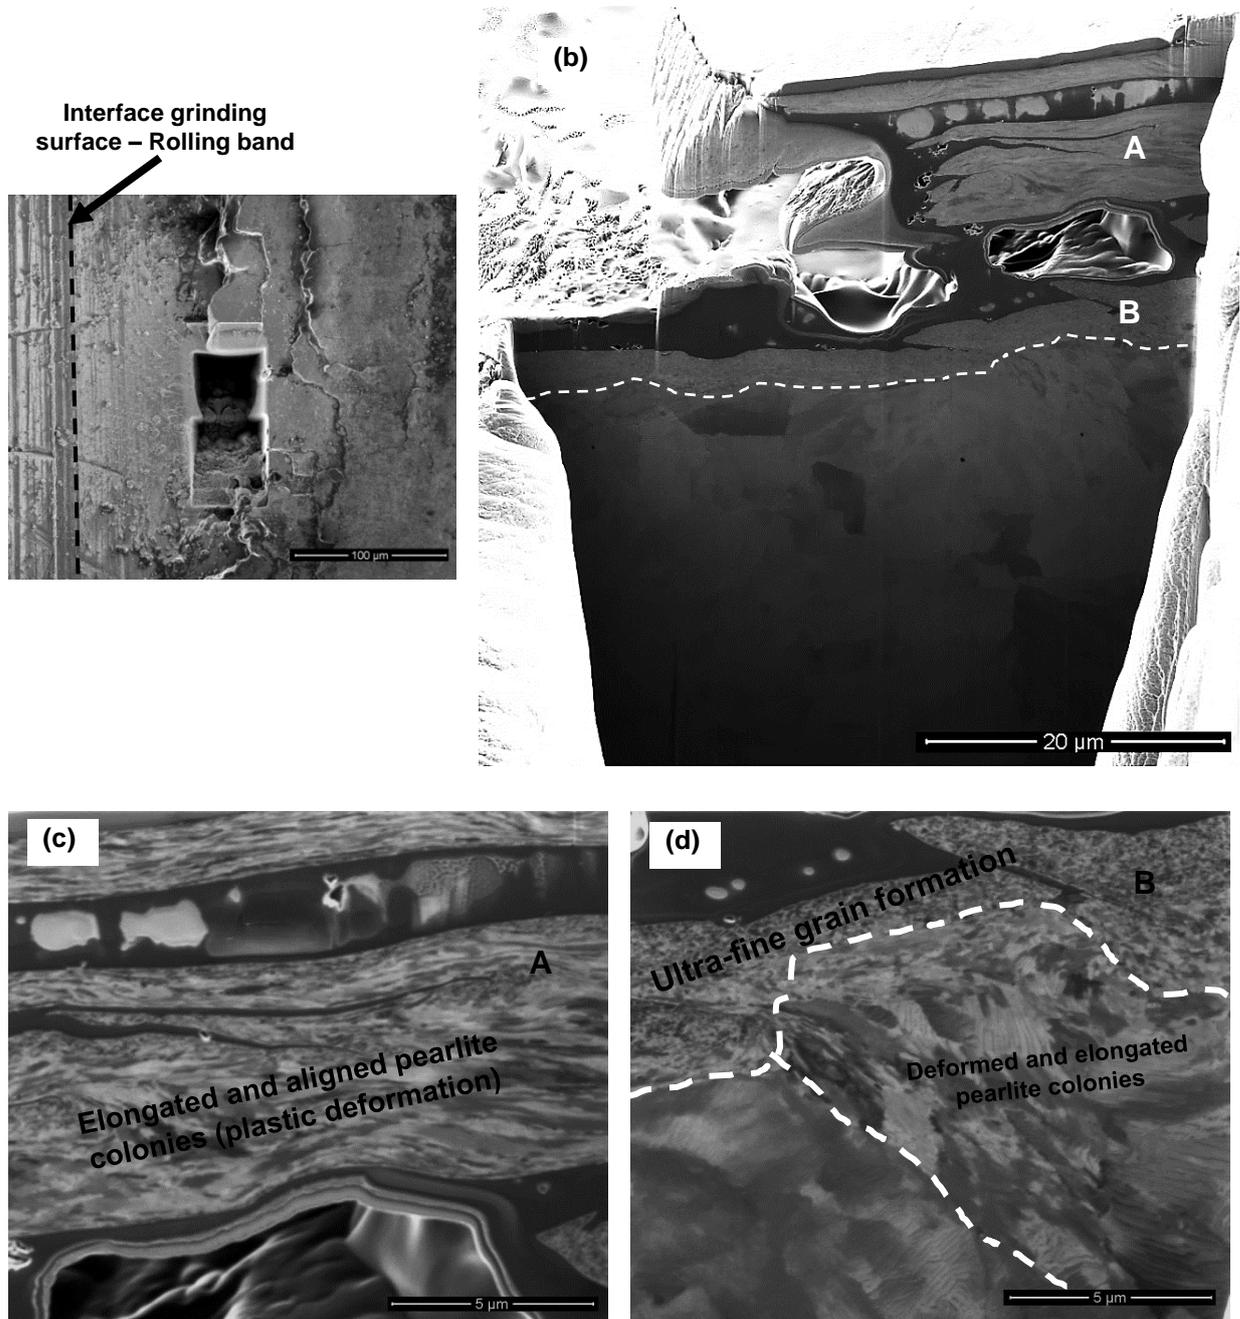
In a sequence, the analysis of the tested samples was carried out. Following the sequence used in the surface characterization, the W4 sample was analyzed in the transition region between the ground surface and the surface affected by the rolling contact as shown in **Figure 4-12**.

Two types of microstructural transformation were observed beneath worn surface (**Figure 4-12b**). In the rolling contact region, a microstructure was observed characterized by elongated and aligned pearlite colonies, whereas the region closely to the grinding preparation, the microstructure consists in ultra-fine grains. The presence of a transition layer was observed beneath the rolling contact region as indicated in the **Figure 4-12c**.

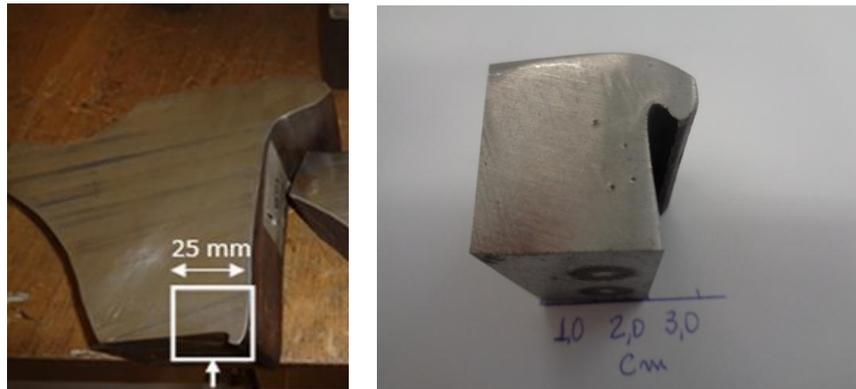
Figure 4-19 Wheel sample used in the microstructural characterization, corresponding with the severely deformed section

The characterization of the microstructural behavior was performed in a sample taken from a worn wheel. The area of interest was selected due severe deformation as indicated in the white box in **Figure 4-19**.

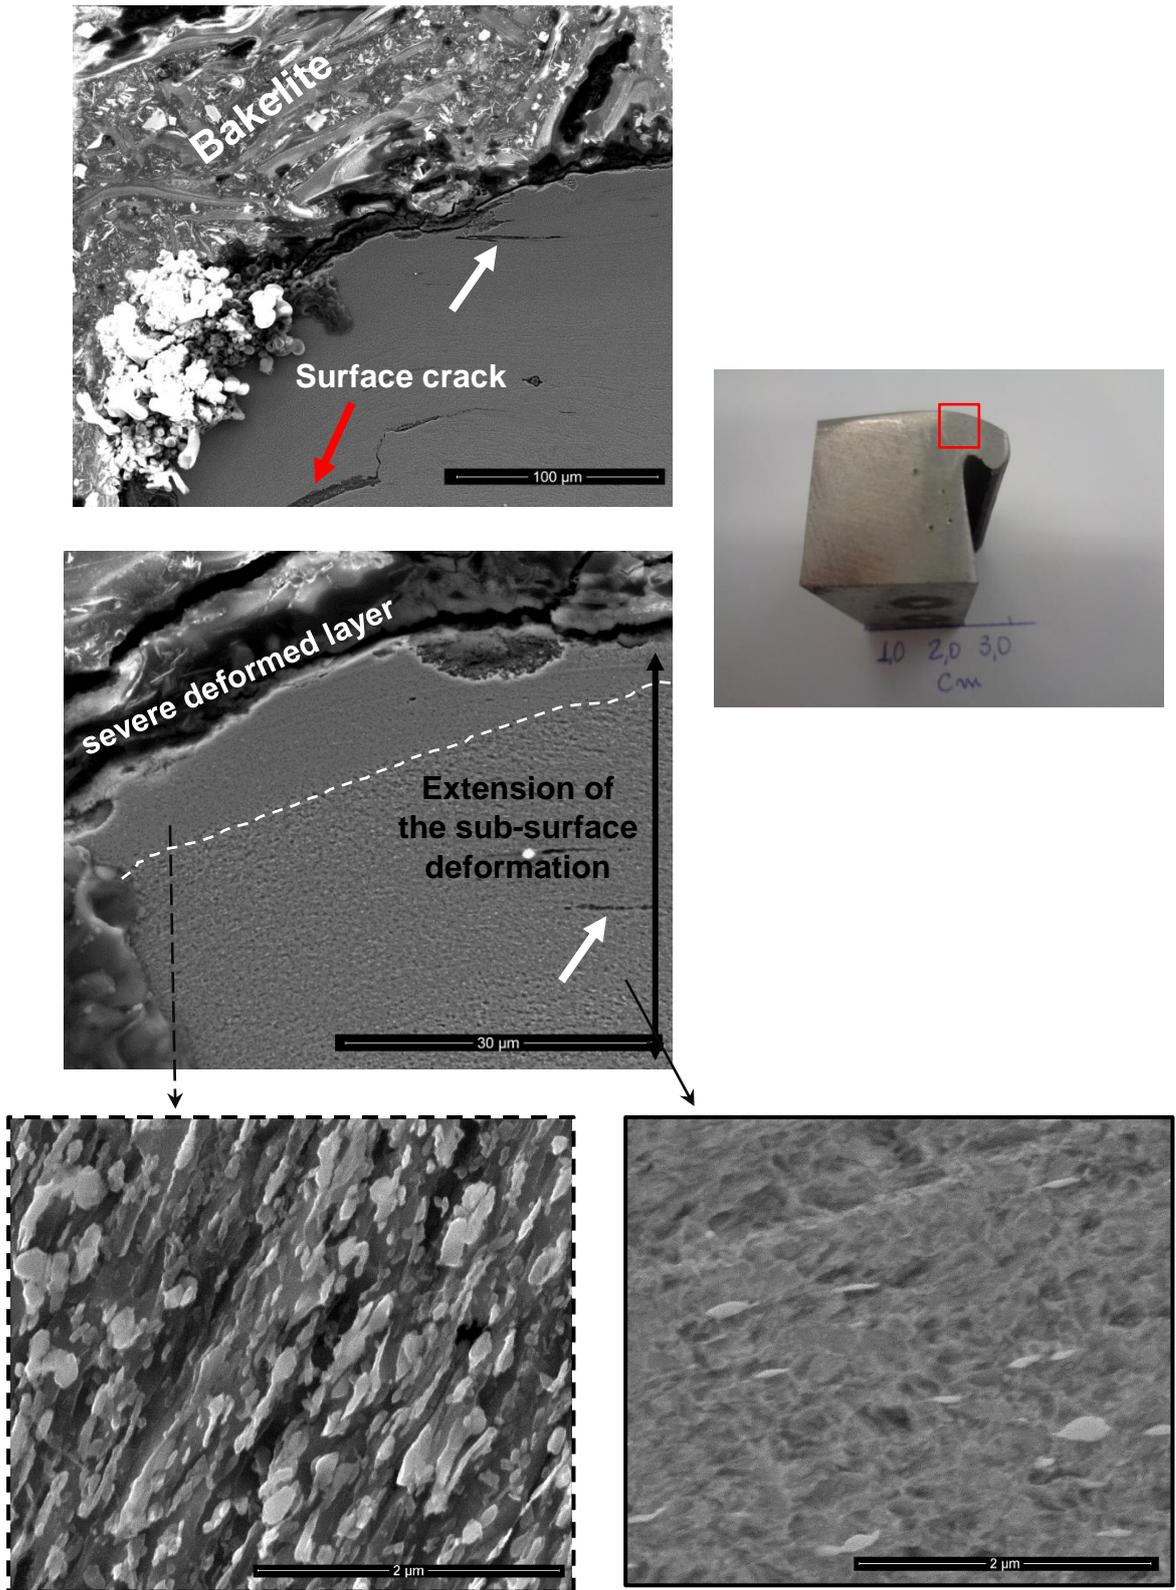
The characterization of a second region in the running band which corresponds to a higher deformation is shown in **Figure 4-23** and indicated by the red box. Two sub-superficial deformed layers were identified at 30 μm from the surface; a severely deformed layer (close to the surface) and a layer plastically affected. The SEM micrograph shows a surface defect (RCF) identified by the black dashed box, an internal crack (white arrow) and a surface crack indicated by the red arrow located in the region with severe plastic deformation.
